**Manchester City Council
Report for Resolution**

Report to: Governance and Resources Scrutiny Committee – 22 June 2017
Subject: National Speedway Stadium: Update
Report of: Strategic Director (Strategic Development)

3.0 The development of the National Speedway Stadium: the Track Failure and the remedies put in place by the City Council

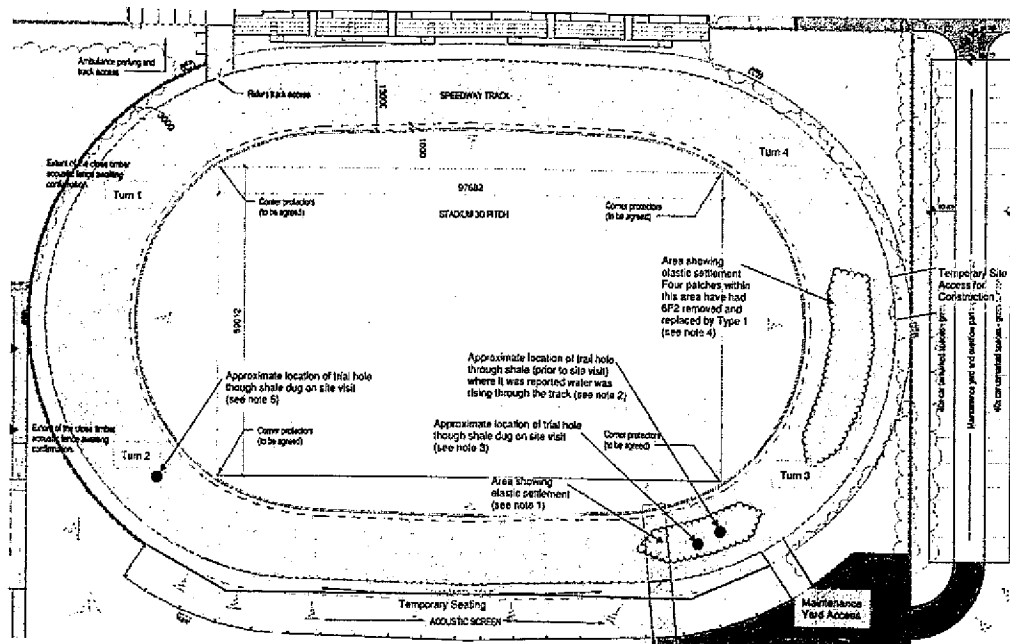
Figure 2 – Initial observation on site (refer to notes below)

1. An area roughly along the centre of the track, close to the temporary seating and the maintenance access, displayed a varying amount of elastic settlement under foot.

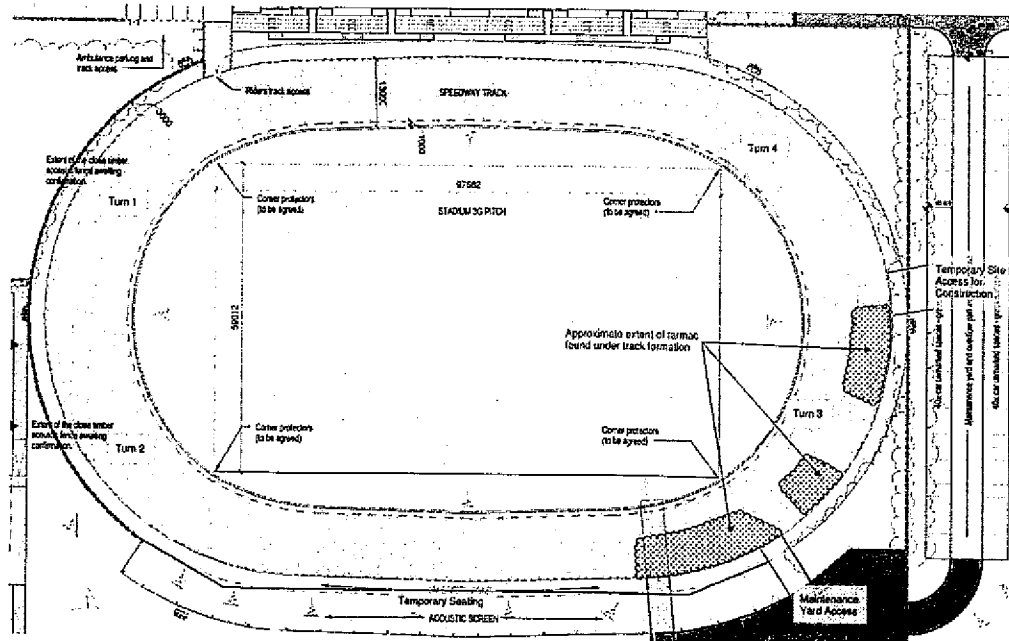
As the works on site progressed it became apparent that some areas of turn 3 were constructed on top of a layer of tarmac. This was thought to be the former hockey pitch surface as the edge of the AstroTurf surface was visible in places. The tarmac layer was about 60mm thick and had a granular sub-base material underneath. The areas that were present were largely intact; they had not been punctured. The tarmac was flat and at such a level as to intersect the sloping formation level of the speedway track at approximately two-thirds of the way from the outside of the curve to the inside. For the outer two thirds of the track the tarmac was intact and levels made up to formation using site-won excavated material. This was essentially a stiff sandy clay material deposited and compacted on top of the tarmac. On the inside third of the track, the tarmac had been removed as part of the track construction and the formation was the former granular material.

Figure 7 - Areas of intact tarmac found at turn 3

The tarmac was present in three areas of turn 3. There is a strong correlation between the positions of the tarmac and the areas showing the worst loss of stiffness on our first site visit. This would indicate that the presence of the tarmac was contributing to the apparent failures in track stiffness. It is assumed the intact tarmac layers were holding water within the capping material layer and the shale layers above, reducing their stiffness. It was Arup's view that the best way to minimise the risk of this occurring again was to puncture the tarmac layer to allow drainage to a deeper depth within the former hockey pitch granular foundation. To do this it would be necessary to remove the sandy-clay fill material on top of it, which should be replaced with a reasonably granular fill. The decision was made to fill the full depth above the tarmac with 100mm layers of type 1 sub-base material, rolling each layer twelve times.

Instruction PMI 114 was issued (dated 18 April 2016) to ISG, subsequent to the previous PMI 113. This specifically was written for the initial area of tarmac found close to the maintenance compound access. This required all material above the tarmac layer to be removed from site, the tarmac broken and levels to be made back up again with compacted type 1 sub-base material.

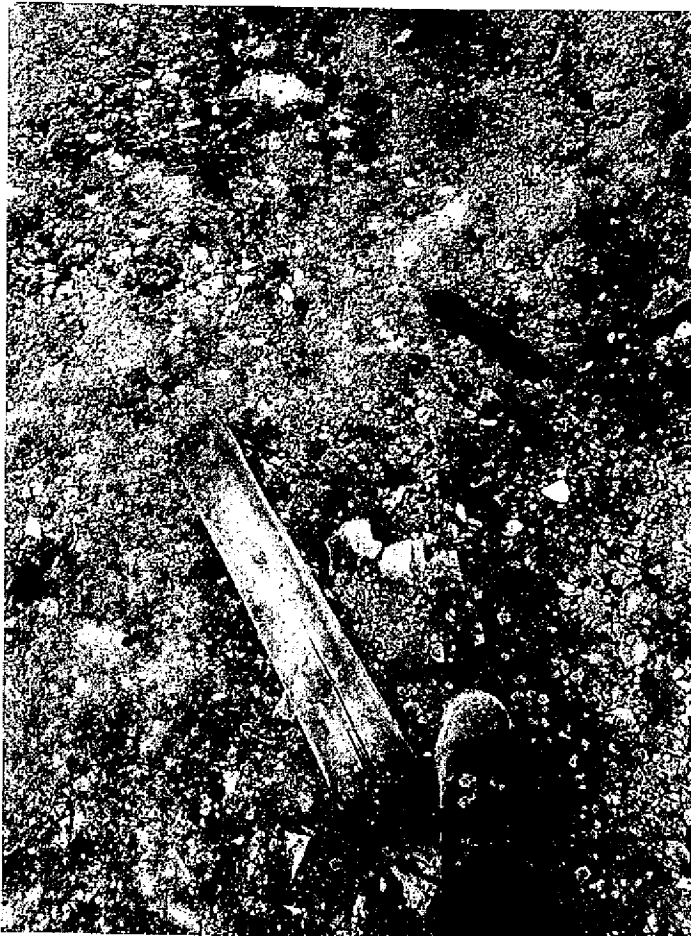
Figure 11 Timber observed in "6F2" material
