2020 7757

## 109 Parsonage Rd

# Structural Investigation Report

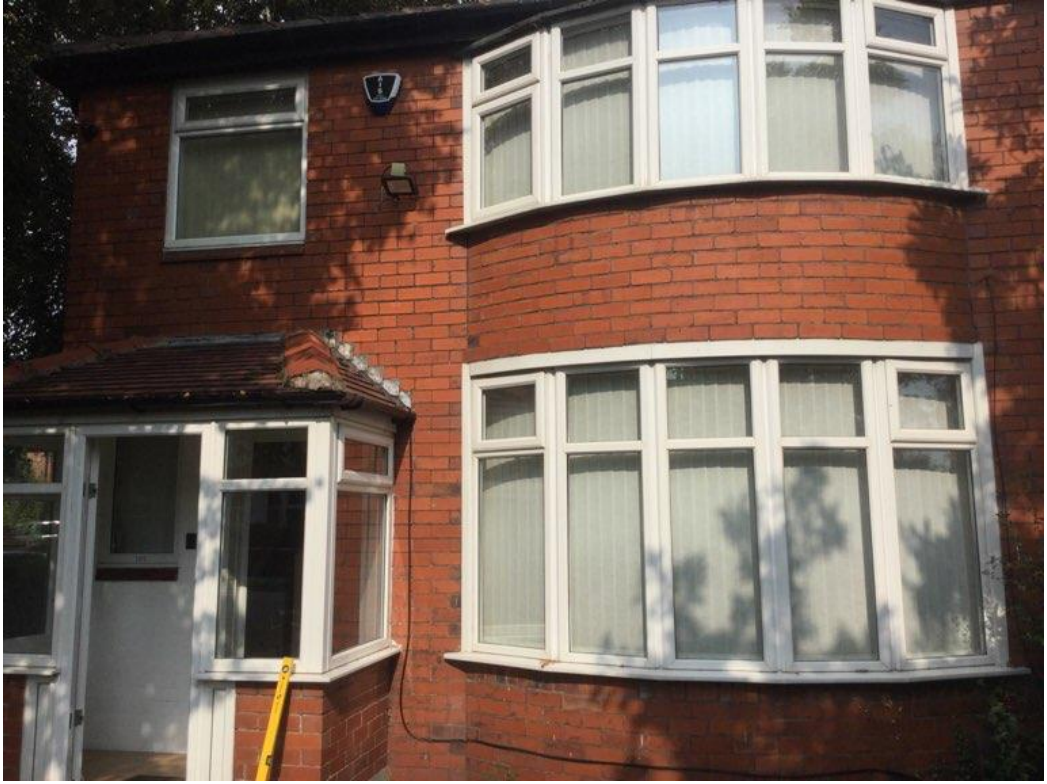
| <b>No</b> | 6.1.1 |

| <b>Description</b> | There is a slight fall on the semi circular bay bed joints back to the main front elevation. |

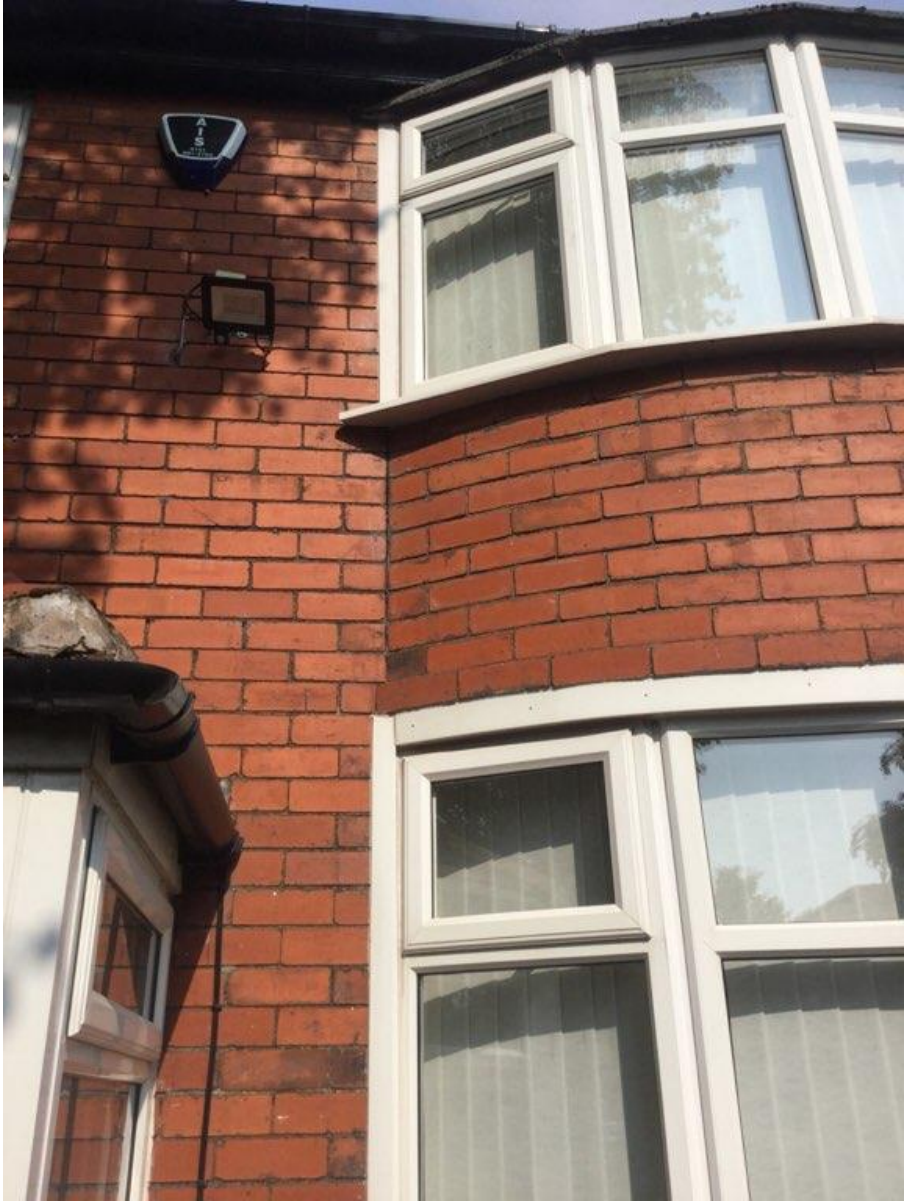
| <b>No</b> | 6.1.2 |

| <b>Description</b> | There is vertical separation cracking of the first floor bay and the front elevation. |

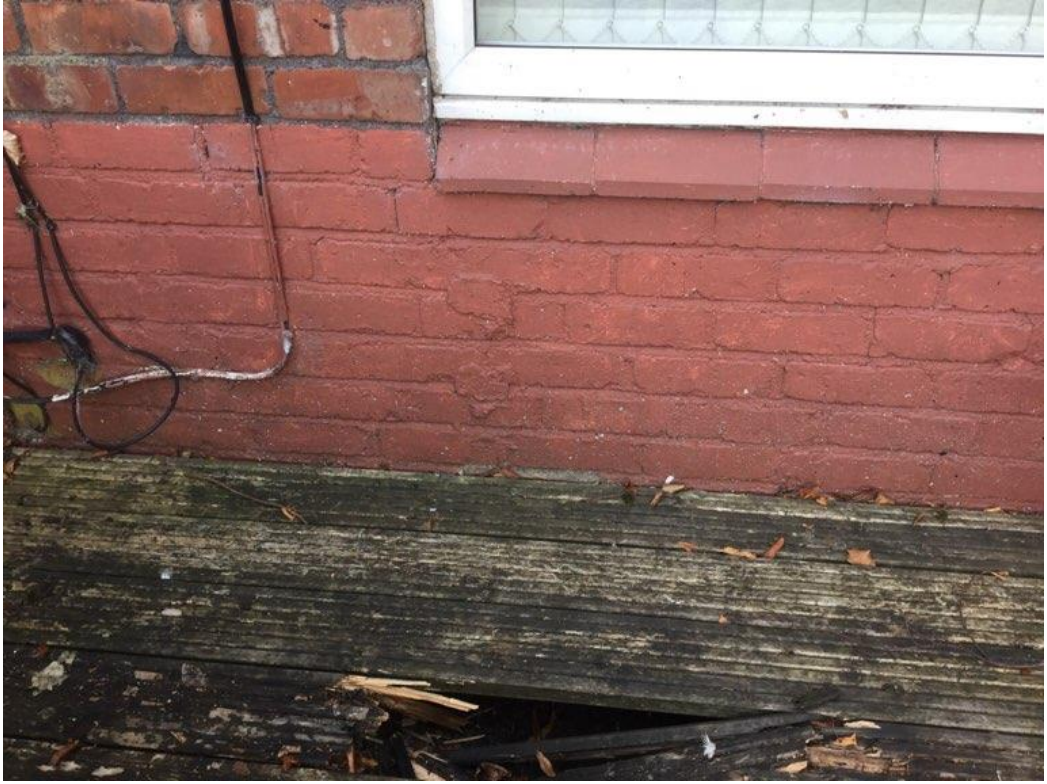
| <b>No</b> | 6.1.7 |

| <b>Description</b> | There is stepped cracking below and to the left and vertical cracking below and to the right of the lounge window as viewed from the rear. |

Once the trees are removed the external cracking can be repaired by the raking out and repointing the mortar joints and internally by redecoration however, it should be noted that some recurrence of cracking may occur in the short to medium term as the ground rehydrates.

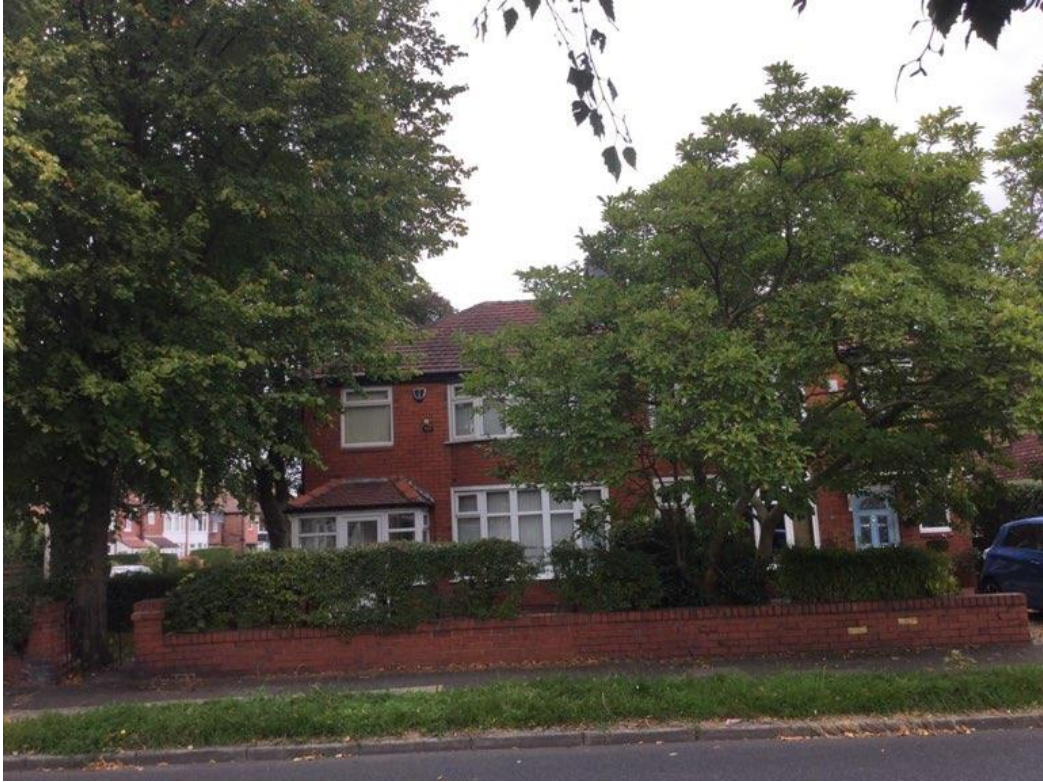
| <b>No</b> | 6.1.8 |

| <b>Description</b> | The front roof slope appears to be to reasonable line and level. |

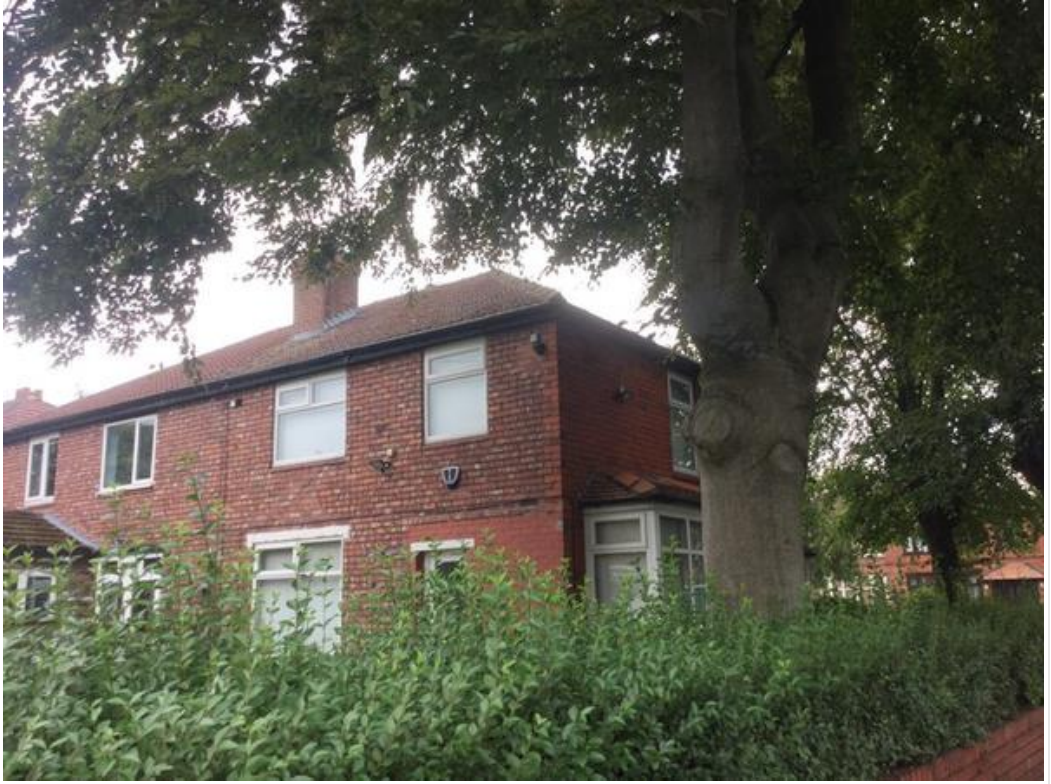
| <b>No</b> | 6.1.9 |

| <b>Description</b> | The side and rear roof slopes appear to be to reasonable line and level. |

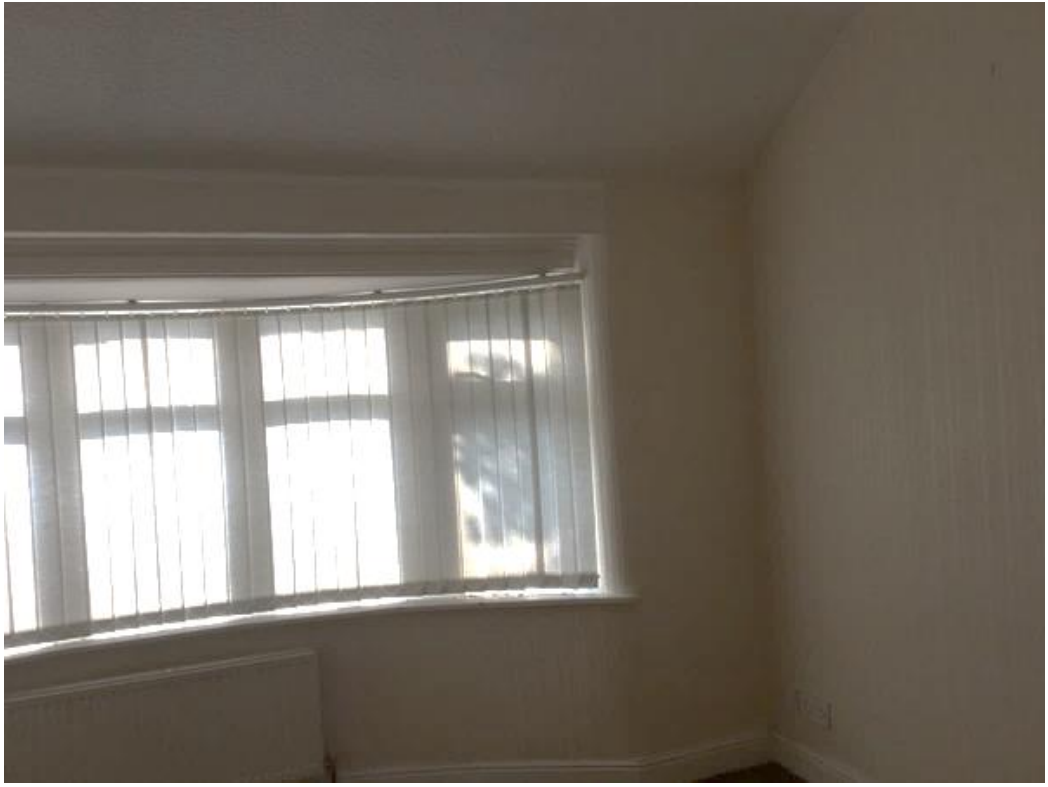
| <b>No</b> | 6.2.1 |

| <b>Description</b> | The room is decorated in old thick wallpaper to the walls and ceiling, there are no obvious signs of distress. |

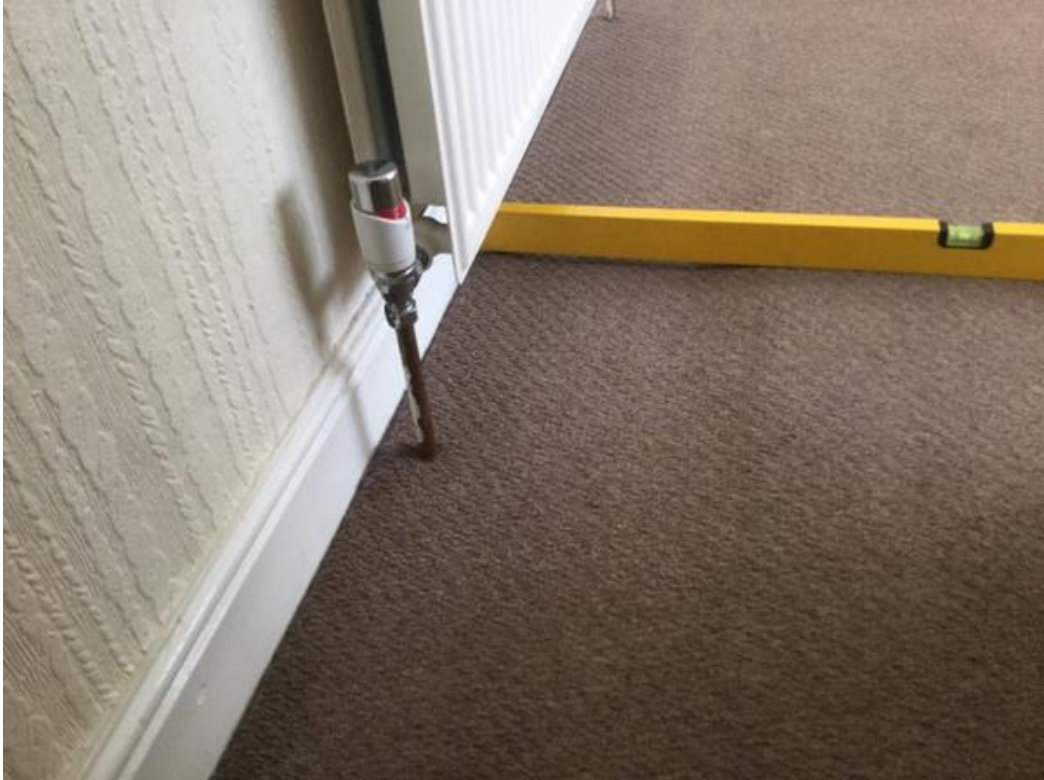
| <b>No</b> | 6.2.2 |

| <b>Description</b> | There is a local dip in the floorboards adjacent to the radiator located on the internal division wall with the rear bedroom. |

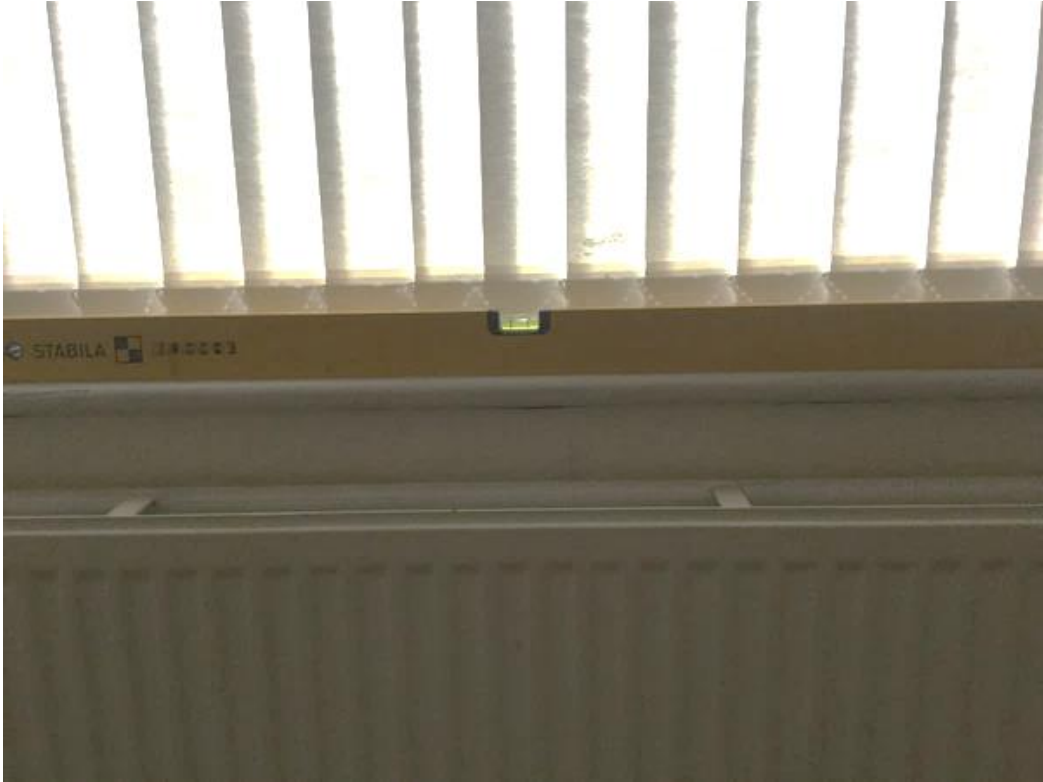
| <b>No</b> | 6.2.4 |

| <b>Description</b> | There is fall on the floor and rear window cill from right to left. |

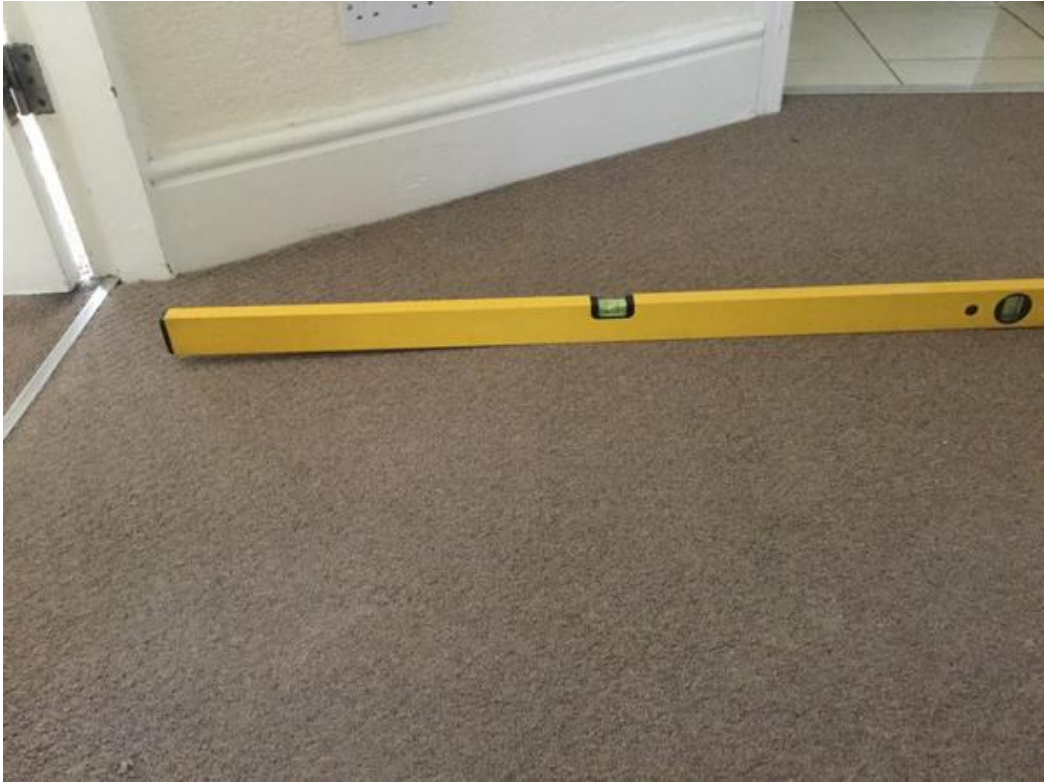
| <b>No</b> | 6.2.7 |

| <b>Description</b> | There is a general fall on the floor from right to left with local dips down to the right and the thresholds of the right hand bedrooms forming a ridge running front to back. |

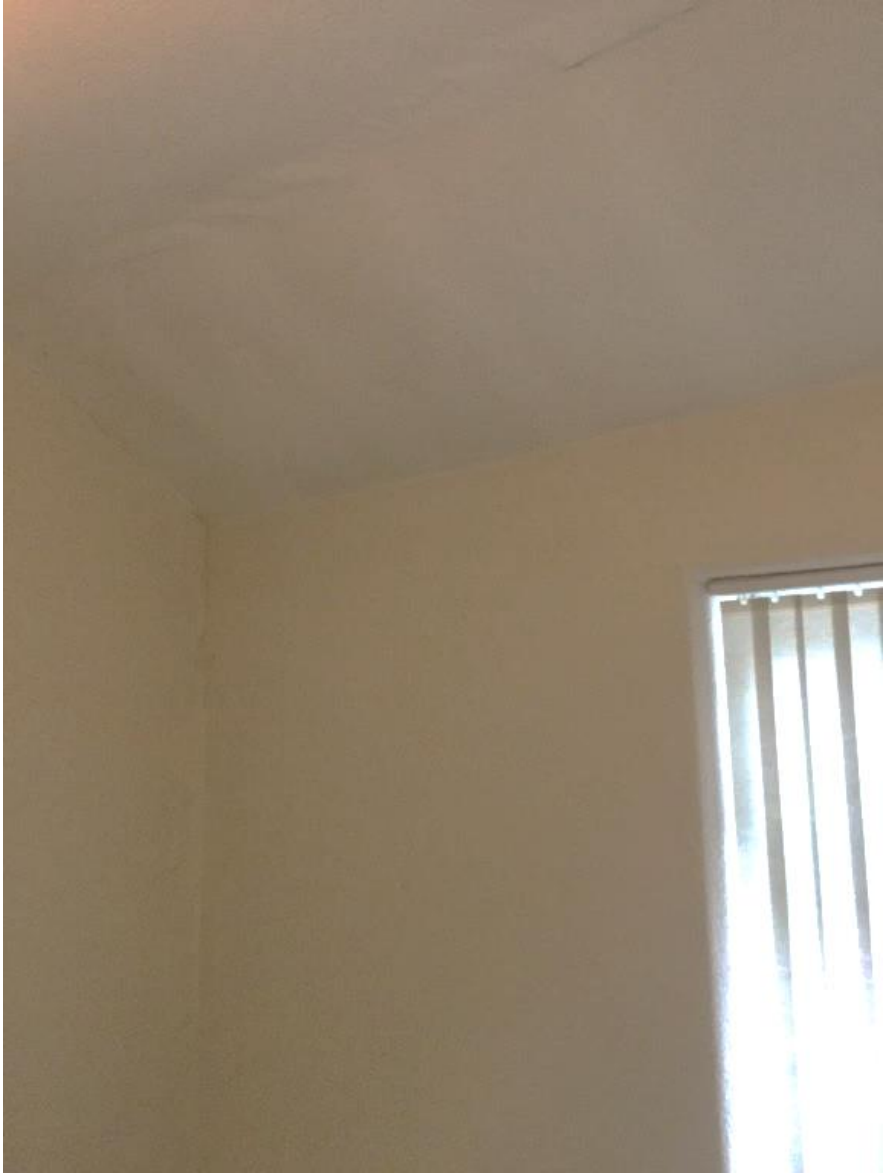
| <b>No</b> | 6.2.8 |

| <b>Description</b> | There is vertical separation of the wallpaper at the junction of the left hand external wall and the division wall of the front left bedroom and landing. There is disturbance of the ceiling at the junction of the vaulted and horizontal sections. |

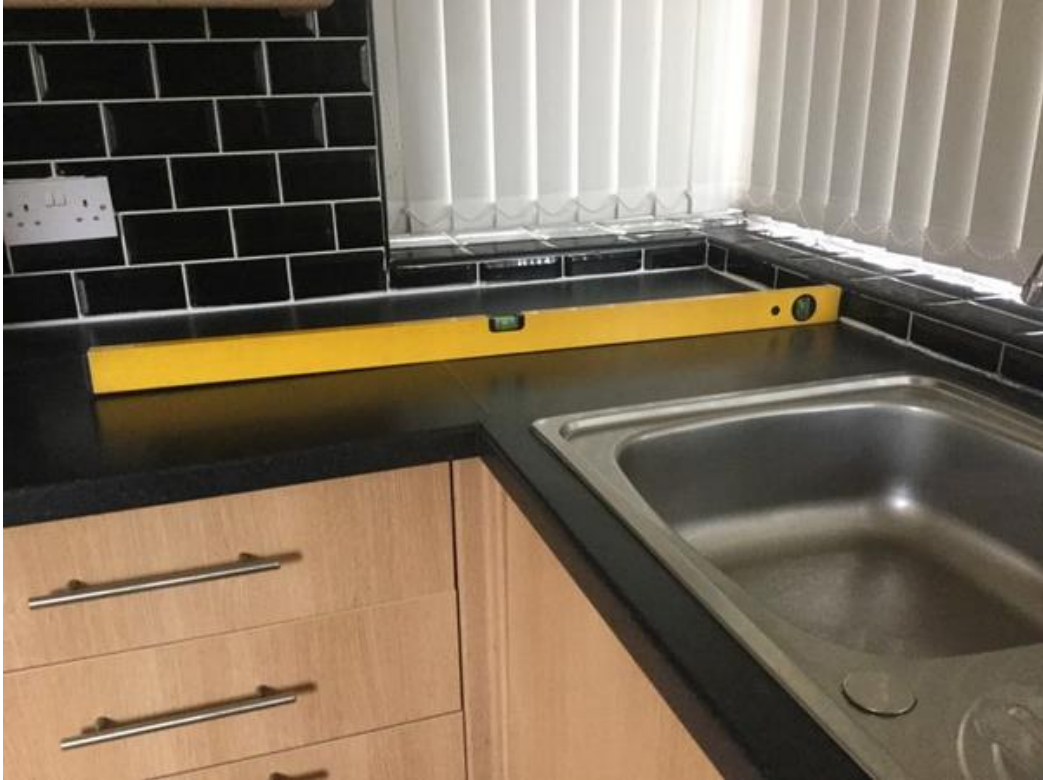
| <b>No</b> | 6.2.9 |

| <b>Description</b> | There is a fall of the side window cills of the bay and kitchen worktop where it projects into bay from right to left. |

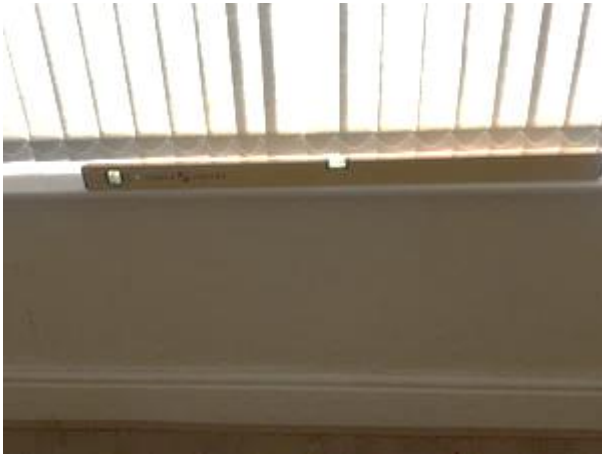
| <b>No</b> | 6.2.10 |

| <b>Description</b> | There is a fall on the window cill from right to left and a slight fall on the floor in the rear left hand corner although the majority of the floor is to reasonable level. |

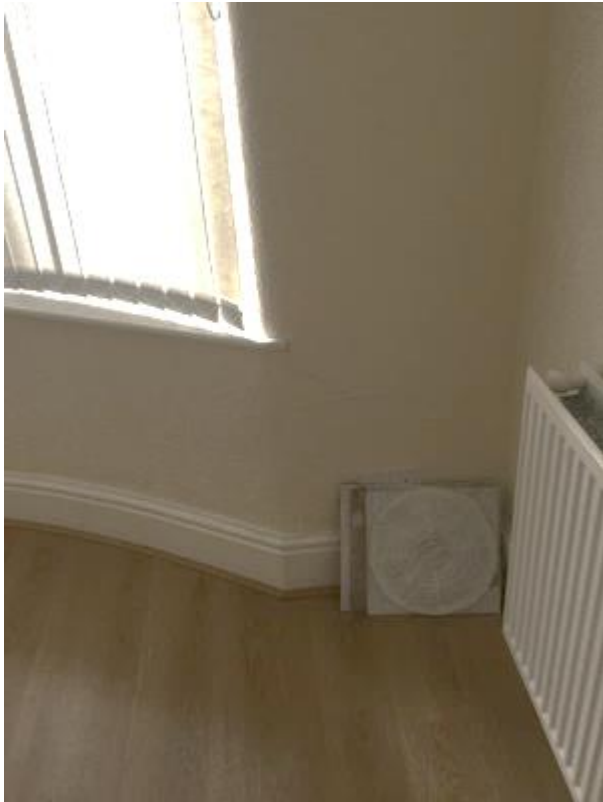
| <b>No</b> | 6.2.11 |

| <b>Description</b> | The bay cill and floor is to reasonable level, there is a short tear in the wallpaper below and to the right of the bay window and viewed from inside the room. |
