2020 7757

109 Parsonage Rd

Structural Investigation Report

Address	109 Parsonage Rd
	Withington
	Manchester
	M20 4WZ

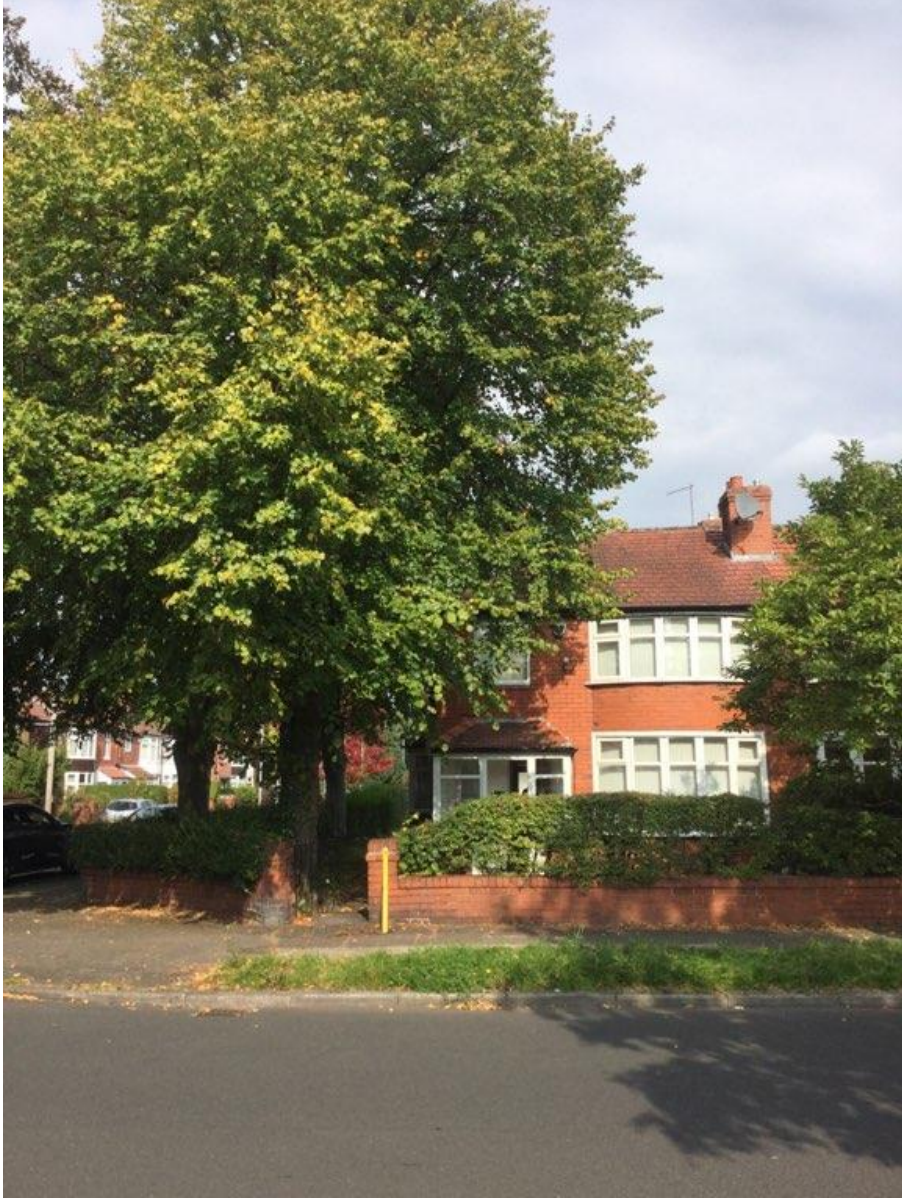
Trees and Vegetation	There are three mature trees located within the boundary of the subject property, one positioned approximately 5 metres forward of the front left hand corner of the house, a second approximately 4 metres to the left of the same corner of the house and a third approximately 4 metres to the left and 4 metres to the rear of the rear left hand corner of the house.
Height of Vegetation	15 - 20 metres
Photograph of Vegetation

There are three mature trees to the left of the property within the garden which are all within the zone of influence of the property. The presence of such large trees so close to the property can be problematical to the foundations and below ground drainage particularly where the foundations bear on clay sub-soils which can become desiccated by the extract of moisture by the tree roots. The drying out of the ground in this way reduces its volume and can result in subsidence of foundations supported on it particularly in times of prolonged dry weather. Movement of this type is usually seasonal with some recover in wetter months and therefore recommendation was given to carry out a trial hole investigation to assess the depth of the foundations, the soil that they bear on to and if clay its susceptibility to shrinkage. Given the more significant movement of the porch and side bay it is likely that these will require strengthening of the foundations in these locations by underpinning, the type and depth require to be established during the trial hole investigation. The further investigation was carried out on the 6th October 2020 and its findings are included in Section 8 of this report and the conclusions based on these findings are included in Section 10.

The movement that can be seen to have occurred to the main house is as a result of differential foundation movement as a result of desiccation of the clay subsoils caused by the presence of the trees. Desiccation being the drying out of the clay by extract of moisture by the action of the tree roots particularly in time of prolonged dry weather or drought, movement of this type is usually seasonal with some recovery during the wetter winter months. Given the size and age of the trees their removal can cause some heave i.e. swelling of the ground in the short to medium term as the ground rehydrates and it is important that specialist advice is sought on the method of removal by a suitably qualified arborculturalist.

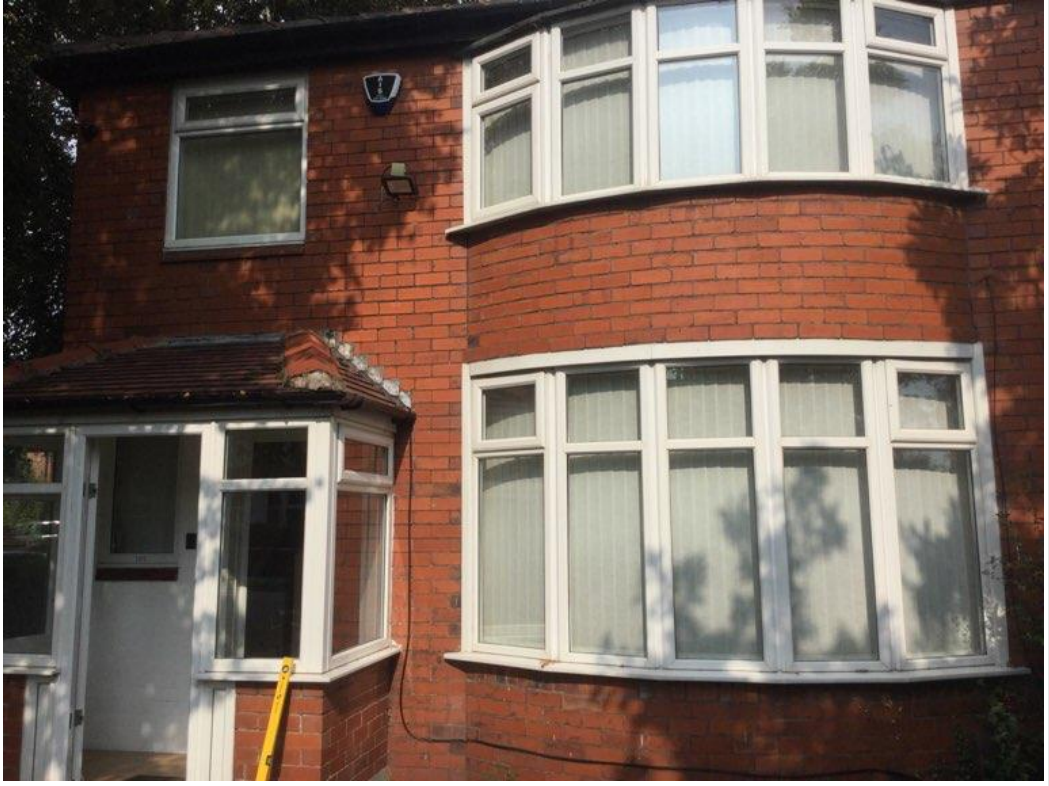
No	6.1.1
Location	Front Elevation
Zone	Elevation Generally
Description	There is a slight fall on the semi circular bay bed joints back to the main front elevation.
Photograph

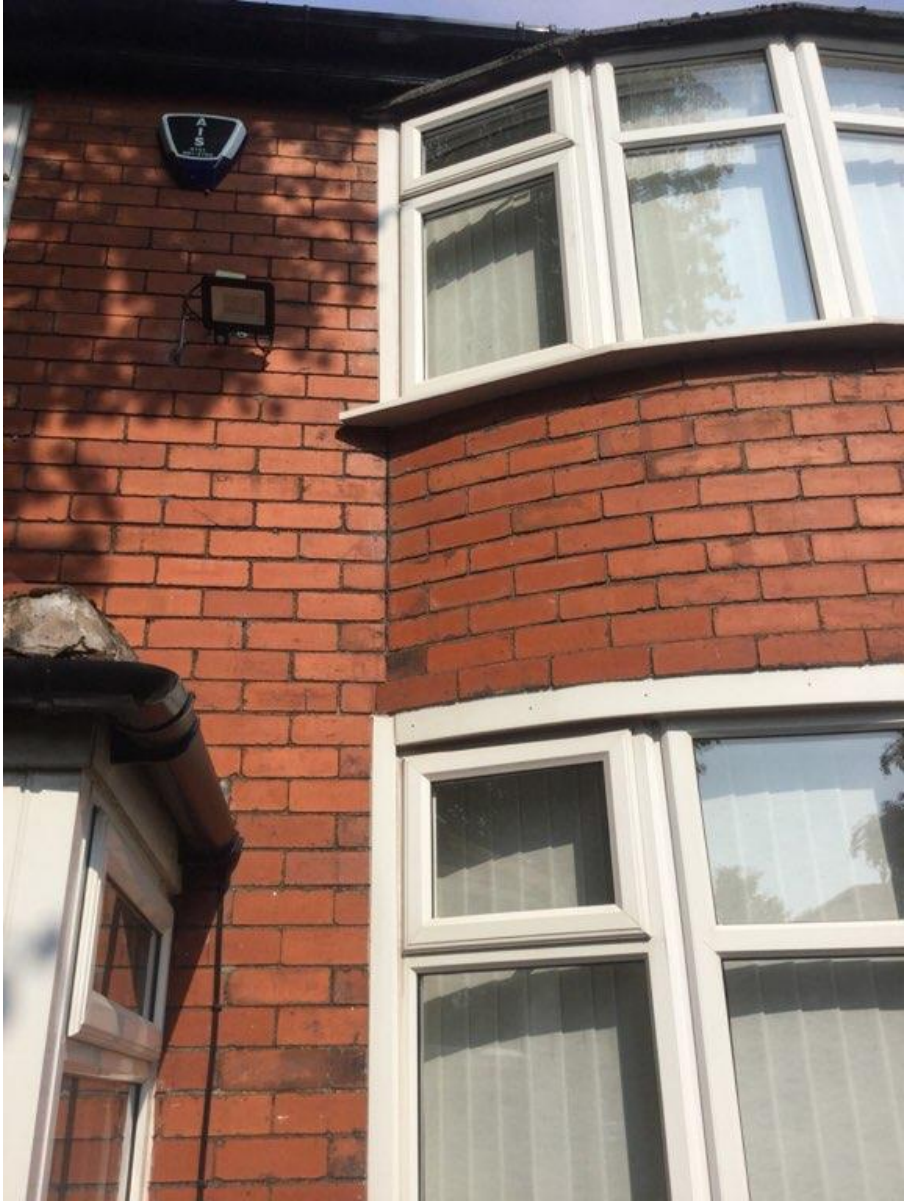
No	6.1.2
Location	Front Elevation
Zone	First Floor Bay
Description	There is vertical separation cracking of the first floor bay and the front elevation.
Photograph

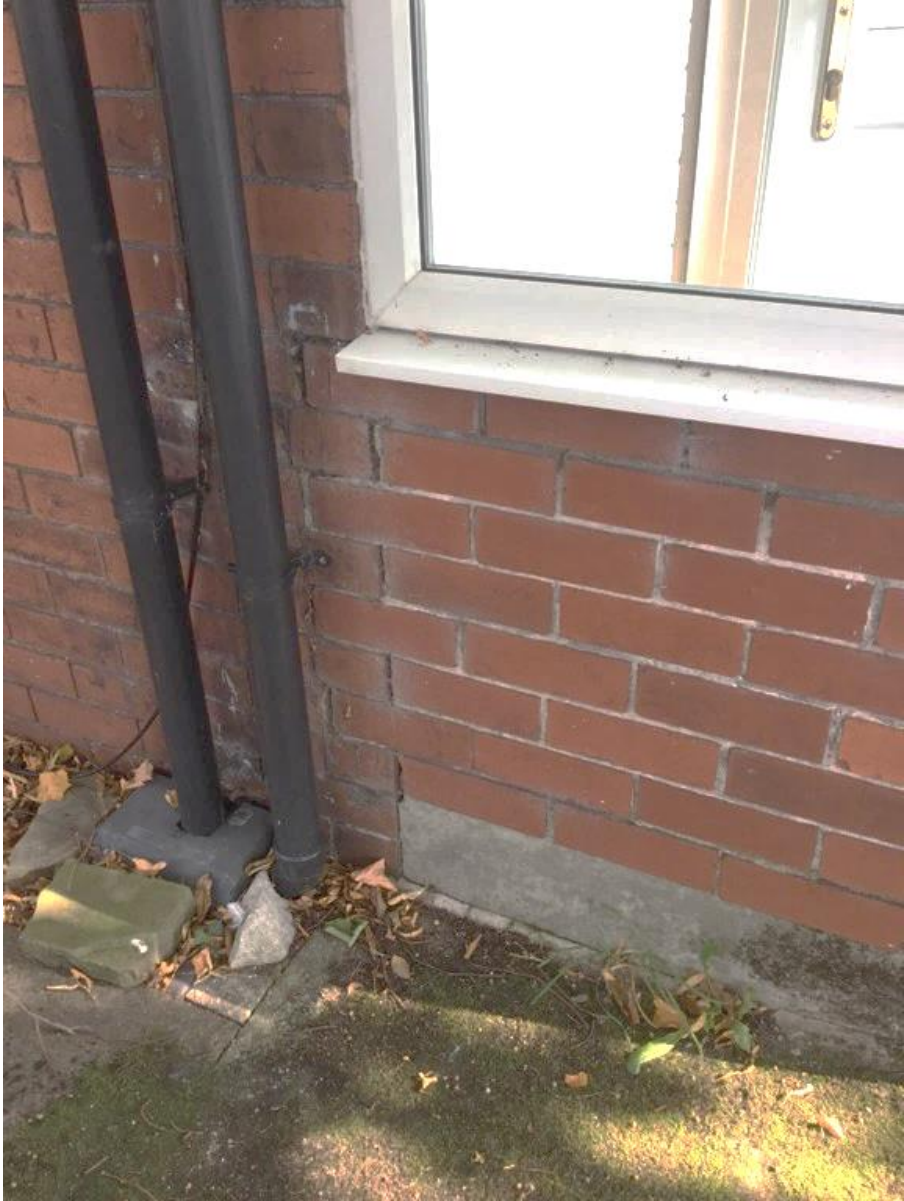
No	6.1.3
Location	Porch
Zone	Brick Coursing
Description	The mortar bed joints fall noticeably from rear to front and slightly from right to left. There is vertical separation cracking at both sides where the porch meets the main front and side elevations.
Photograph

The foundation movement that has occurred to the porch and side bay is as a result of inadequate foundations and if retained these will require underpinning to bear on suitable bearing strata, the movement that has currently occurred has not damaged the main house and therefore underpinning or removal is not considered to be urgent however, should they be retained without any remedial works this situation should be monitored for further signs of damage.

Should the entrance porch and side bay be retained a typical budget for underpinning would be in the region of £3000 and £5000 + VAT respectively.

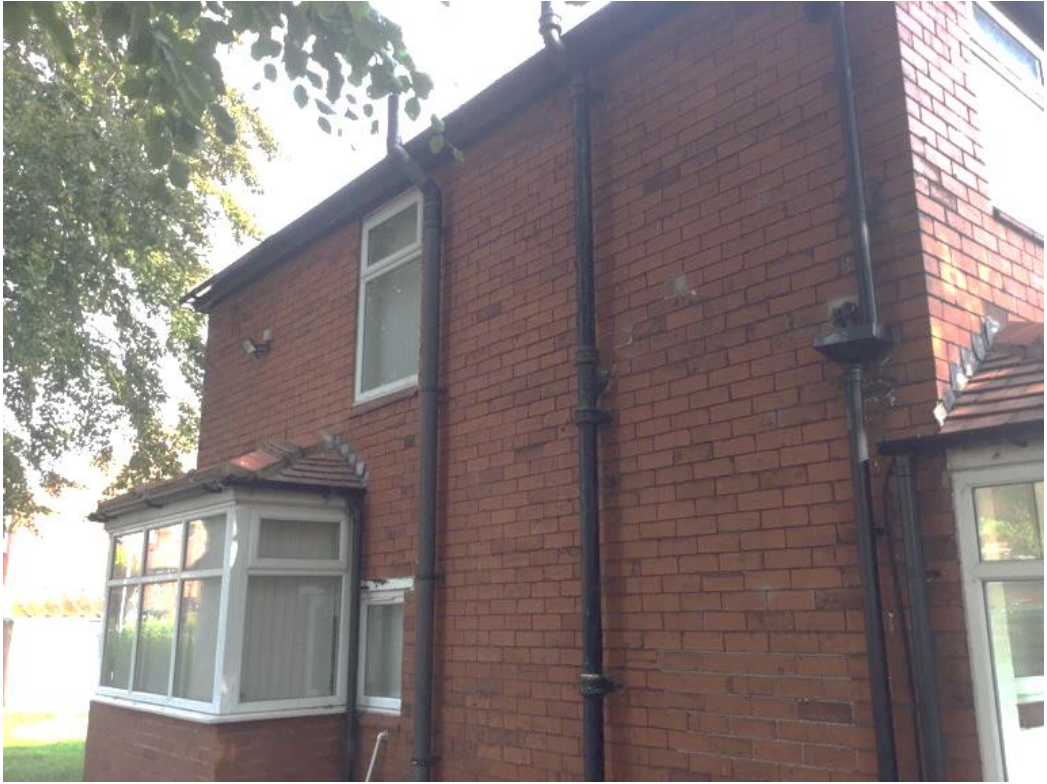
No	6.1.4
Location	Left Elevation
Zone	Elevation Generally
Description	There is some slight undulation from vertical of the elevation. The mortar bed joints are to reasonable level.
Photograph

Elsewhere the elevations were noted to have some slight out of plane movement most notably to the left hand elevation where a ripple effect could be seen to the outer leaf, movement of this type in cavity walls is usually associated with corrosion of the wall ties prior to failure. Properties of this age and type typical contain thin wire butterfly ties to connect the inner and outer leaves of masonry and these are particularly susceptible to corrosion over time. A separate inspection of the wall ties has been carried out by Atlas Survey and Building Services which noted surface corrosion of the wall ties at low level we would therefore recommend that remedial wall ties are installed in the short to medium term to prevent any further lateral movement of the outer leaf.

We would recommend that remedial wall ties are installed in the short to medium term typical cost £1000-1200 + VAT.

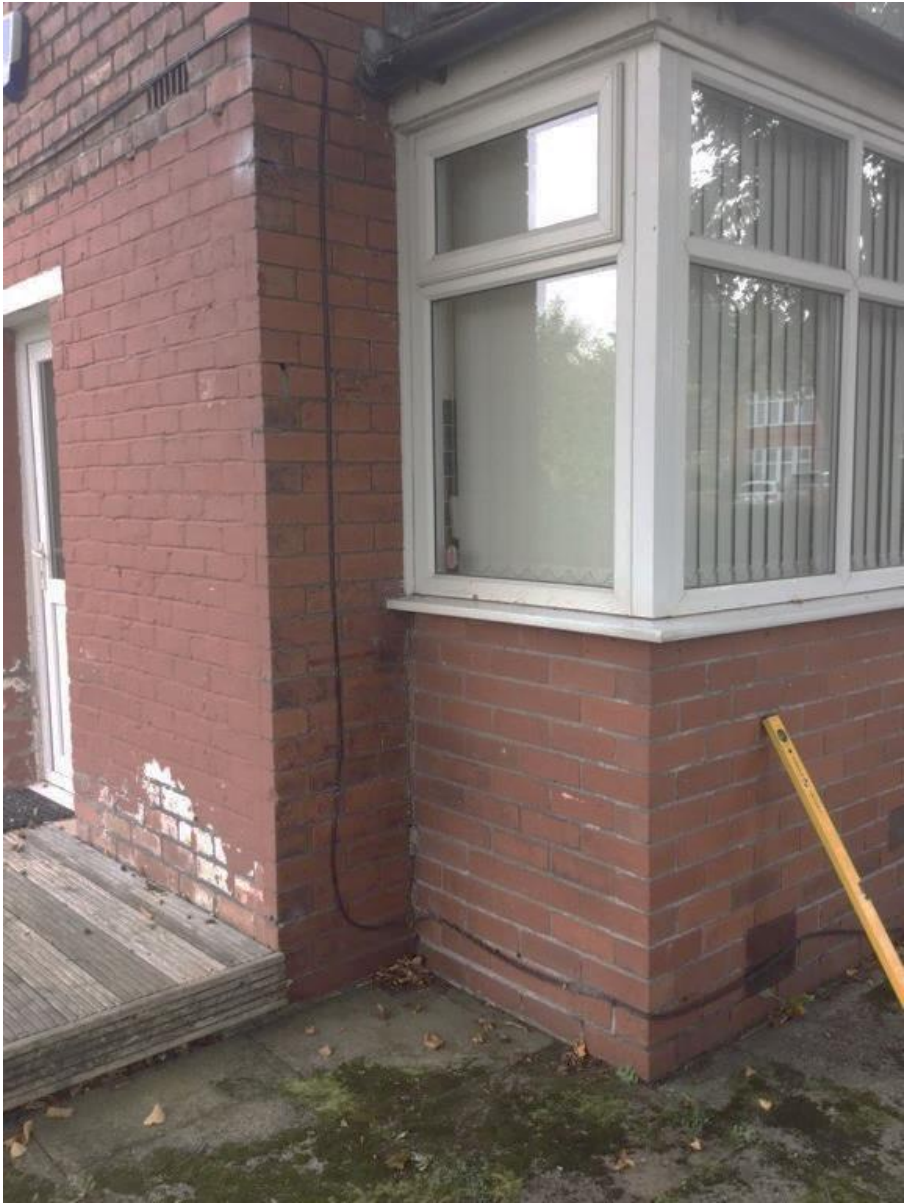
No	6.1.5
Location	Left Elevation
Zone	Single Storey Side Bay
Description	There is a noticeable fall of the bed joints from right to left and to a lesser degree from rear to front with vertical separation cracking at the junction with the left hand elevation.
Photograph

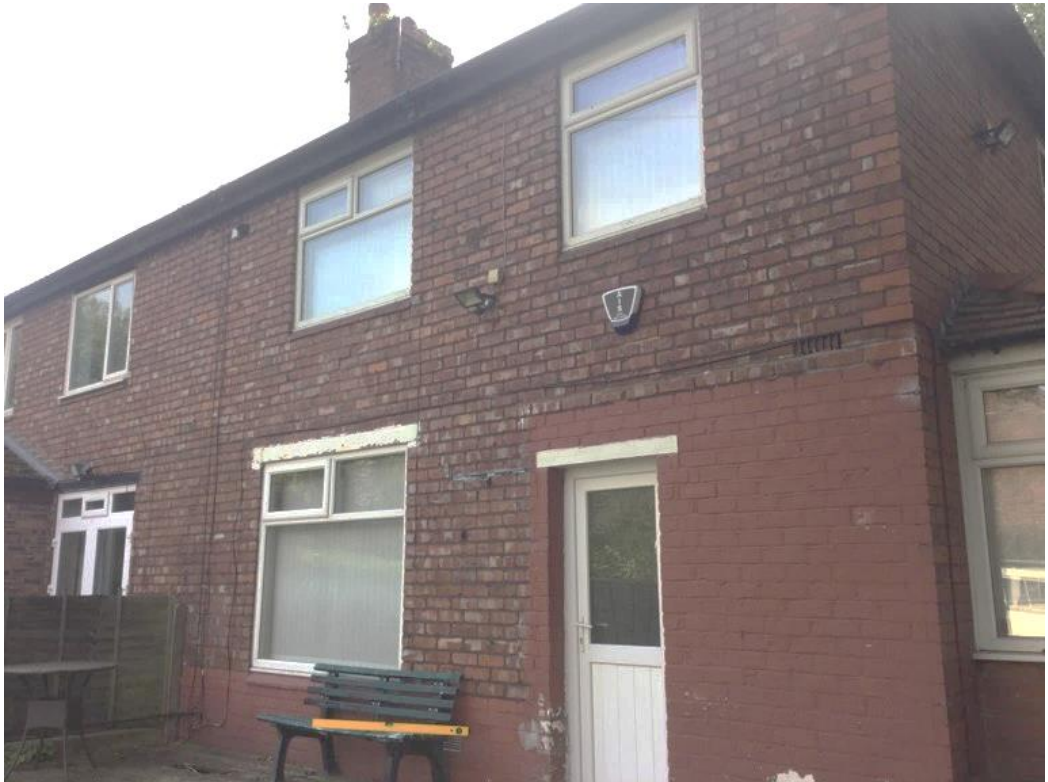
No	6.1.6
Location	Rear Elevation
Zone	Brick Coursing
Description	There is a general fall on the mortar bed joints from left to right as viewed from the rear. The elevation is to reasonable verticality with some very slight undulations.
Photograph

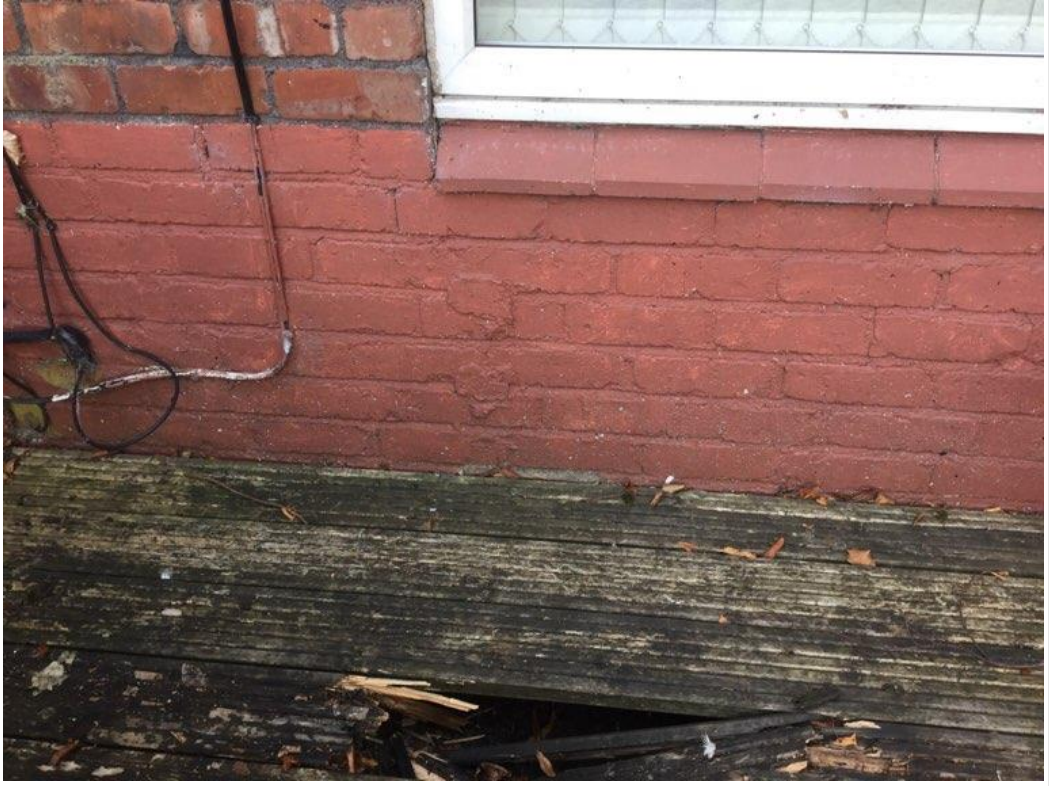
No	6.1.7
Location	Rear Elevation
Zone	Below Window
Description	There is stepped cracking below and to the left and vertical cracking below and to the right of the lounge window as viewed from the rear.
Photograph

Once the trees are removed the external cracking can be repaired by the raking out and repointing the mortar joints and internally by redecoration however, it should be noted that some recurrence of cracking may occur in the short to medium term as the ground rehydrates.

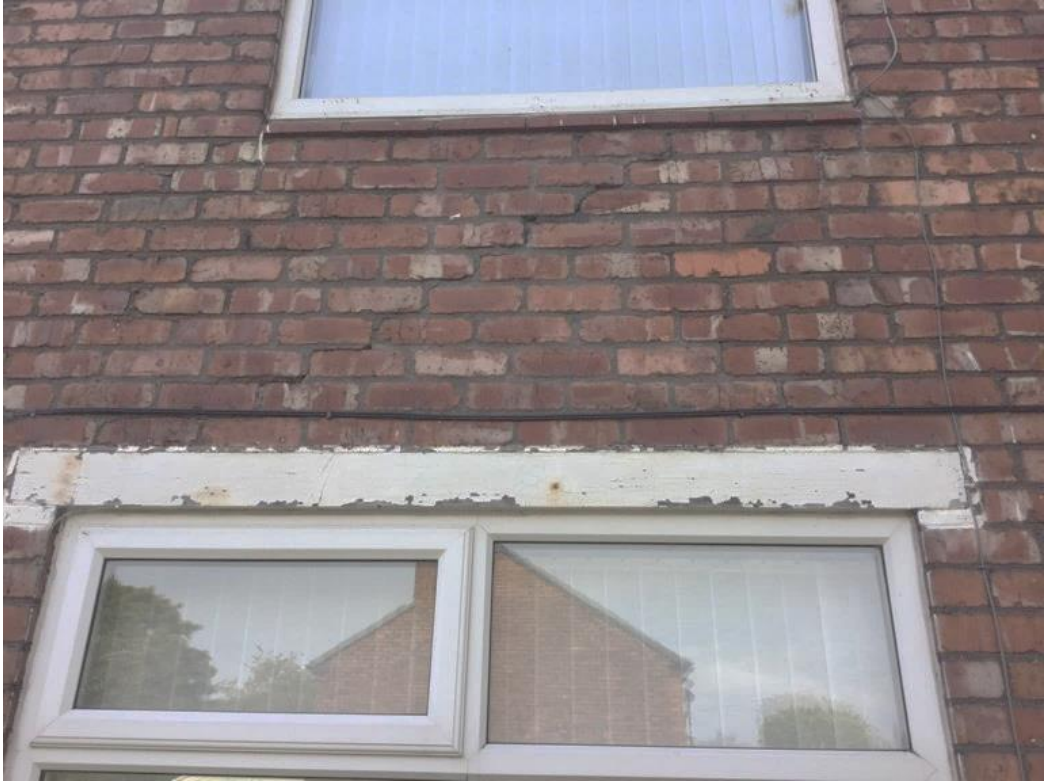
No	6.1.8
Location	Rear Elevation
Zone	Over Window
Description	There is a stepped crack from the top left of the lounge window projecting up and to the right all as viewed from the rear.
Photograph

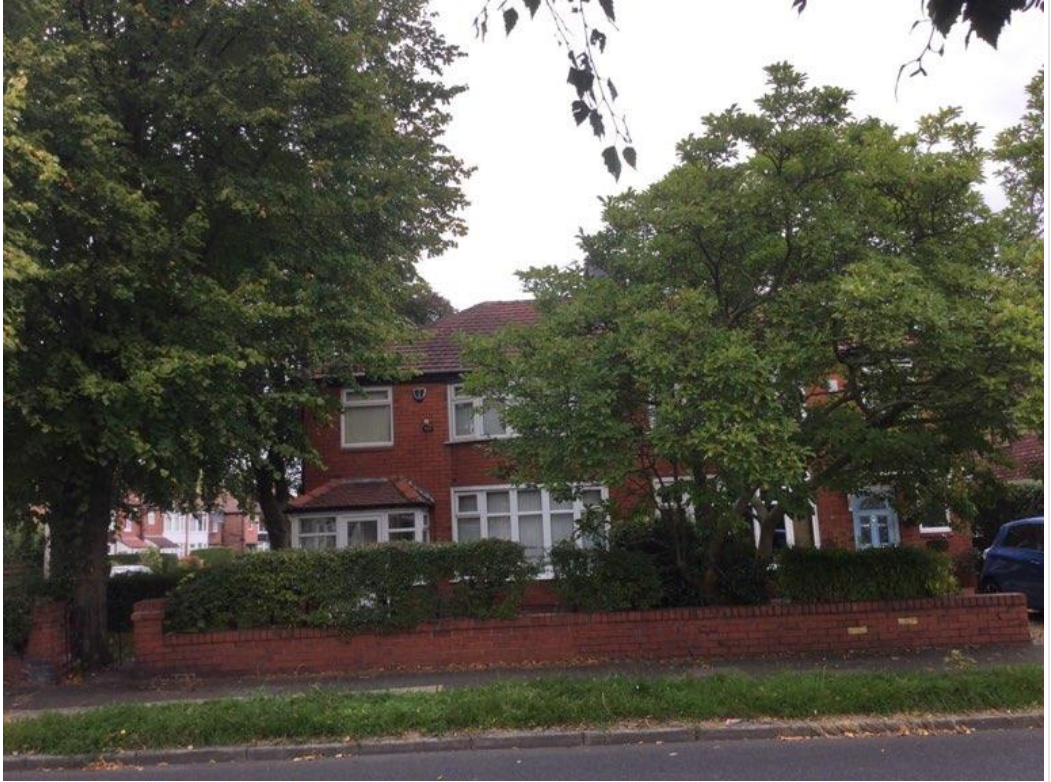
No	6.1.8
Location	Roof
Zone	General Observation
Description	The front roof slope appears to be to reasonable line and level.
Photograph

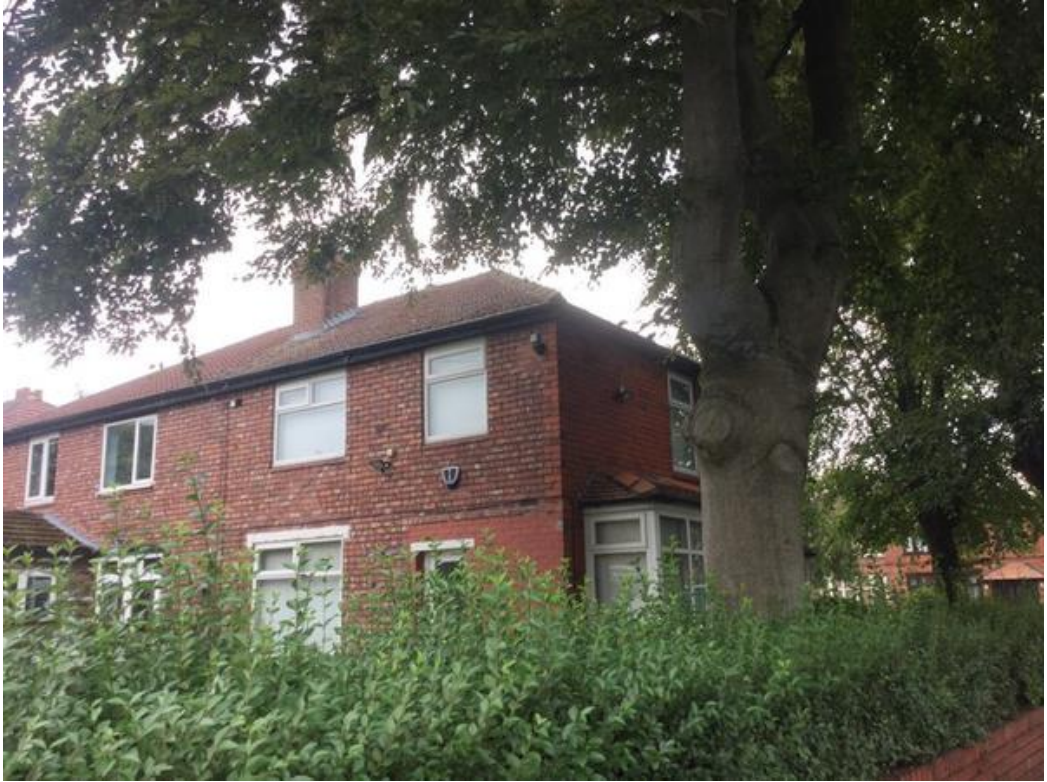
No	6.1.9
Location	Roof
Zone	General Observation
Description	The side and rear roof slopes appear to be to reasonable line and level.
Photograph

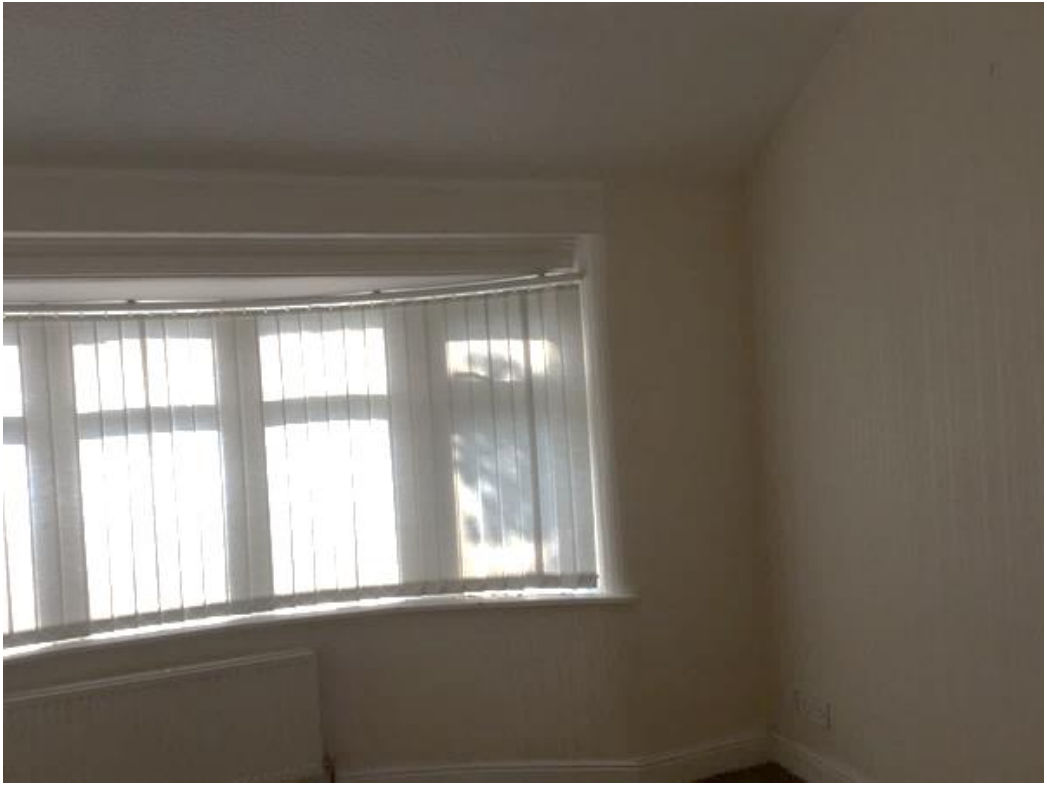
No	6.2.1
Location	First Floor, Front Right Bedroom
Zone	General Observation
Description	The room is decorated in old thick wallpaper to the walls and ceiling, there are no obvious signs of distress.
Photograph

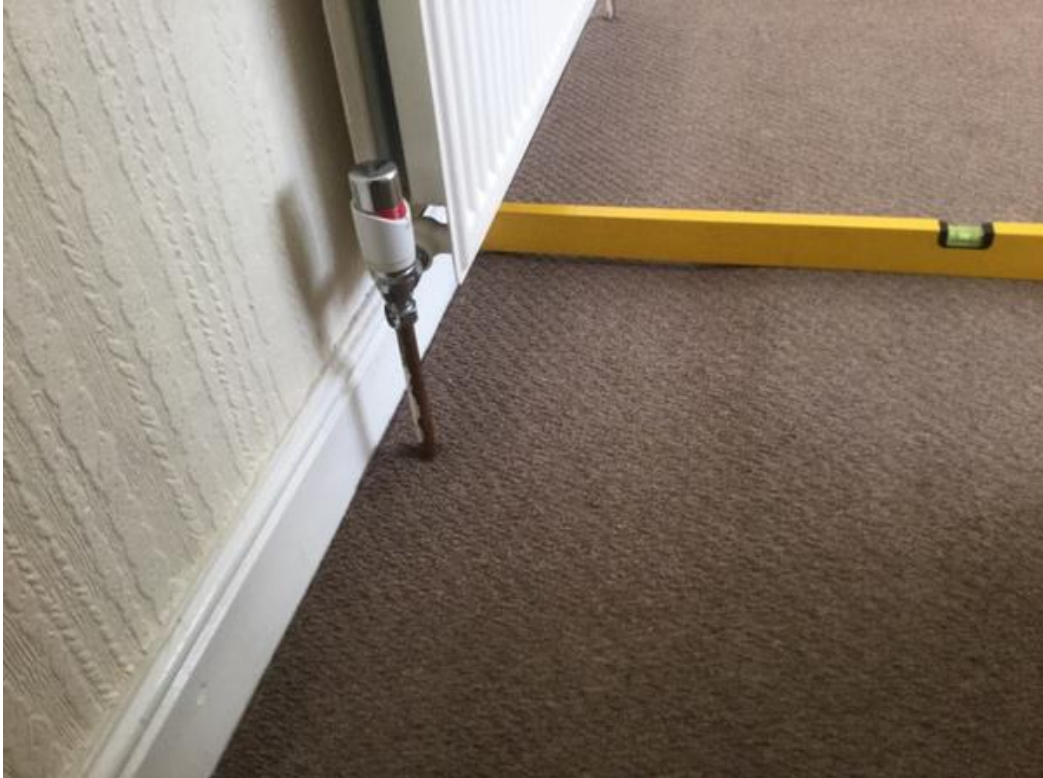
No	6.2.2
Location	First Floor, Front Right Bedroom
Zone	Floor
Description	There is a local dip in the floorboards adjacent to the radiator located on the internal division wall with the rear bedroom.
Photograph

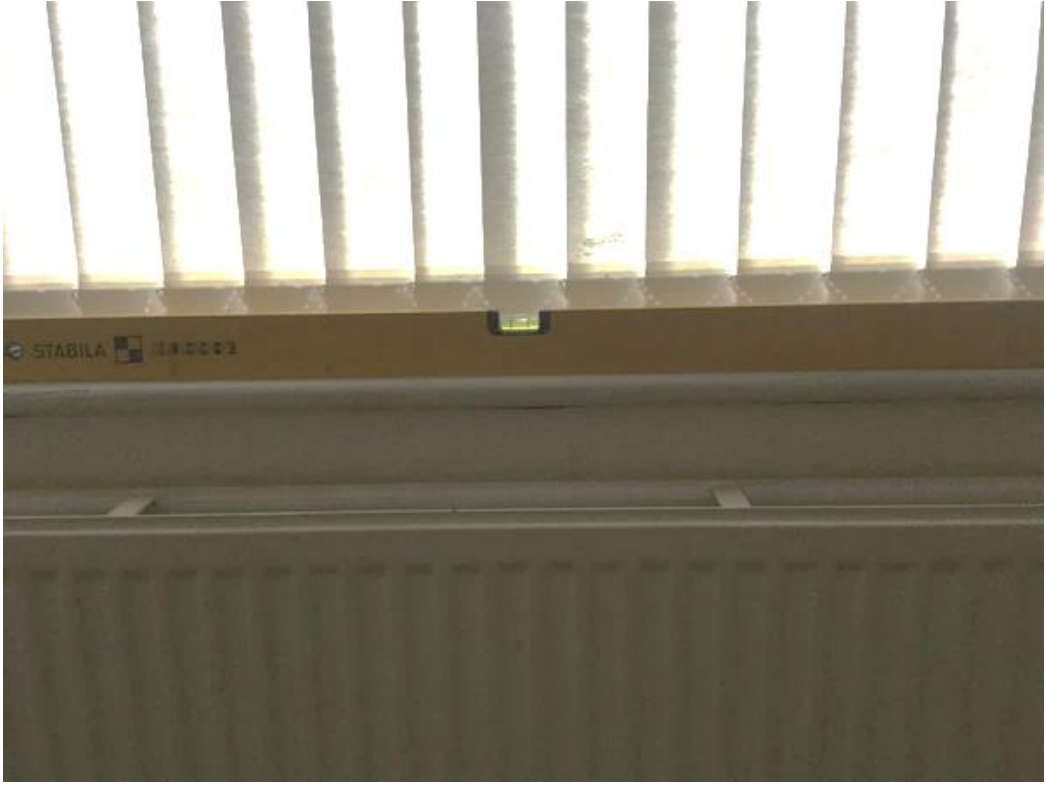
No	6.2.3
Location	First Floor, Bathroom
Zone	General Observation
Description	There is a slight fall on the floor from right to left and a slight outward lean on the left hand external wall. The is disturbance to the wallpaper to the ceiling.
No	6.2.4
Location	First Floor, Bedroom
Zone	Floor
Description	There is fall on the floor and rear window cill from right to left.
Photograph

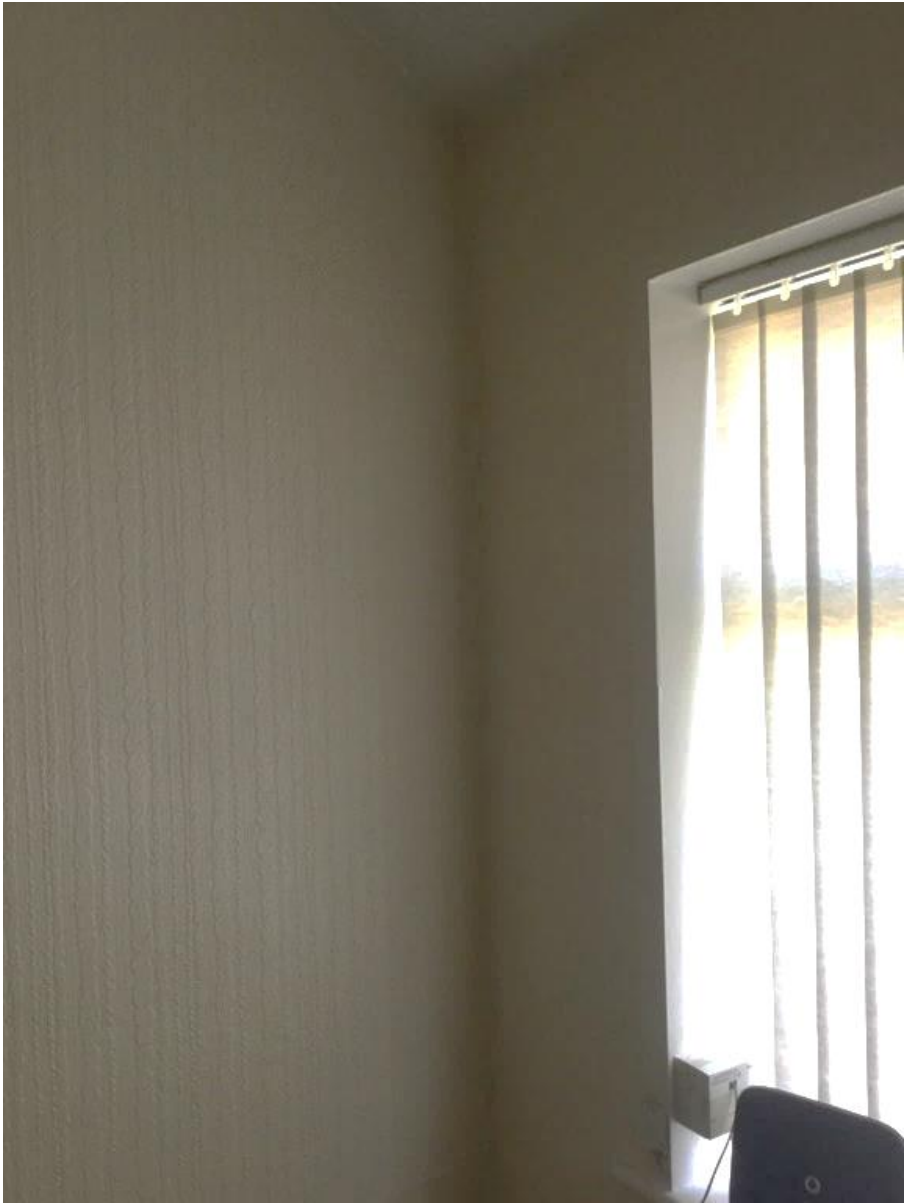
No	6.2.5
Location	First Floor, Rear Right Bedroom
Zone	Internal wall, External Wall
Description	There is a slight outward lean of the rear wall to the left of the window and rucking of the wallpaper at the junction with the internal division wall to the rear left bedroom.
Photograph

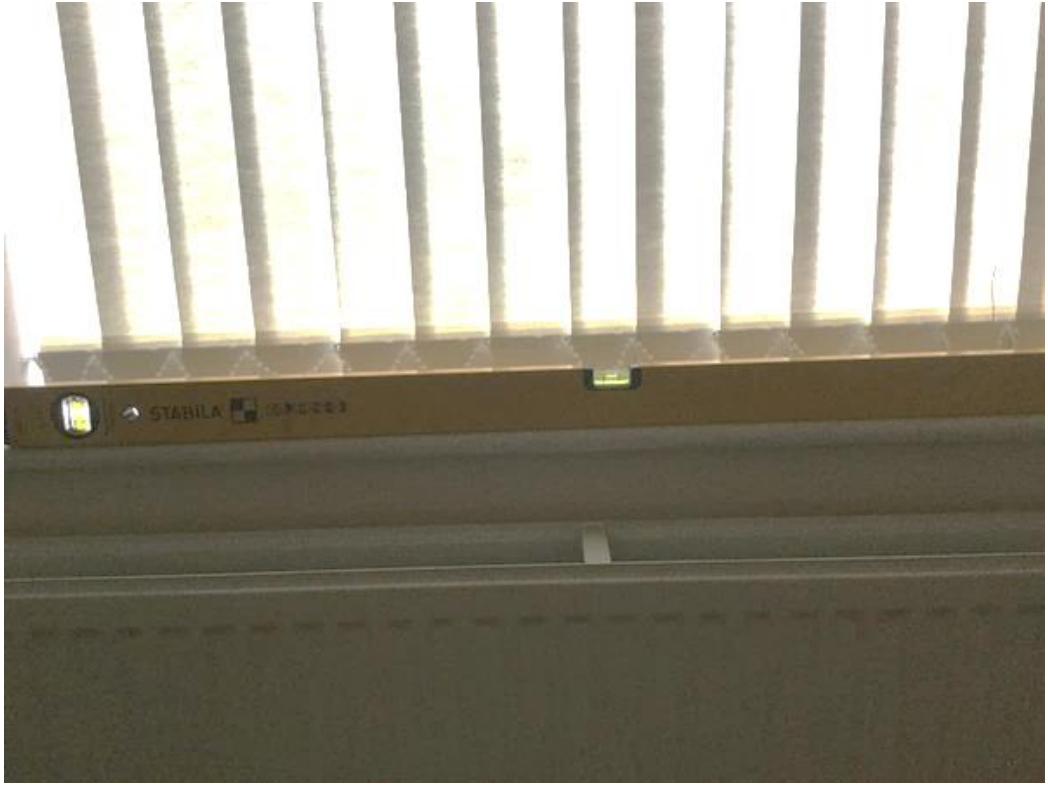
No	6.2.6
Location	First Floor, Rear Left Bedroom
Zone	General Observation
Description	There is a very slight fall on the rear window cill from right to left, the floor and external walls are to reasonable level and vertical respectively.
Photograph

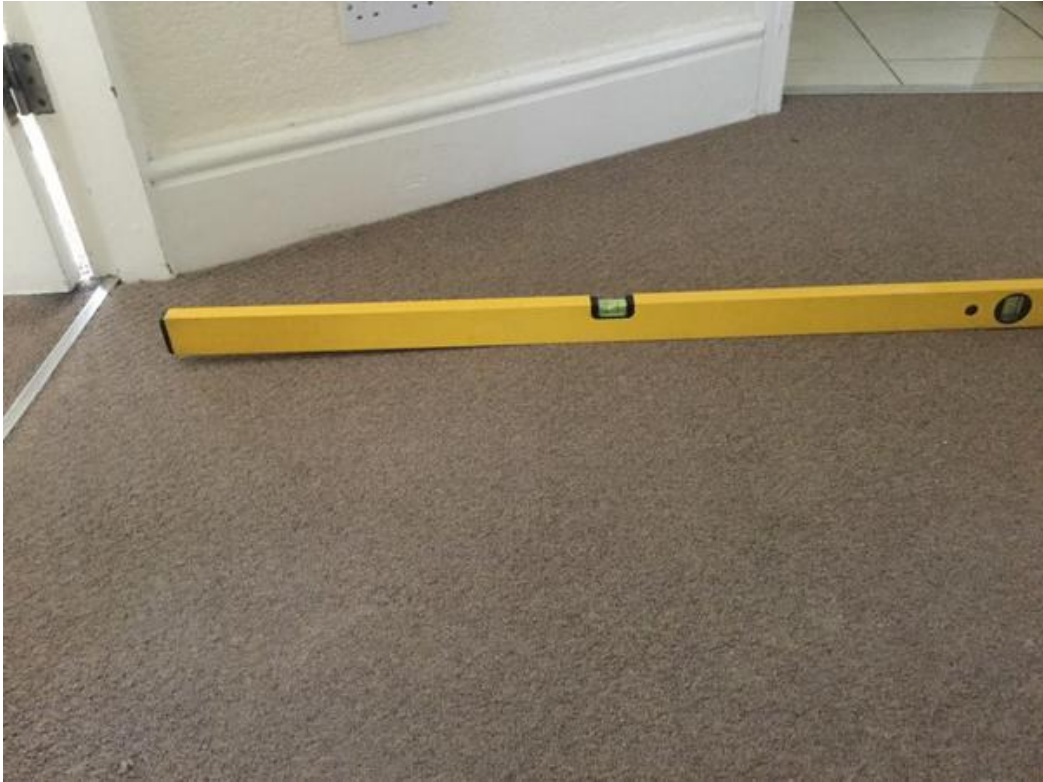
No	6.2.7
Location	First Floor, Hall
Zone	Floor
Description	There is a general fall on the floor from right to left with local dips down to the right and the thresholds of the right hand bedrooms forming a ridge running front to back.
Photograph

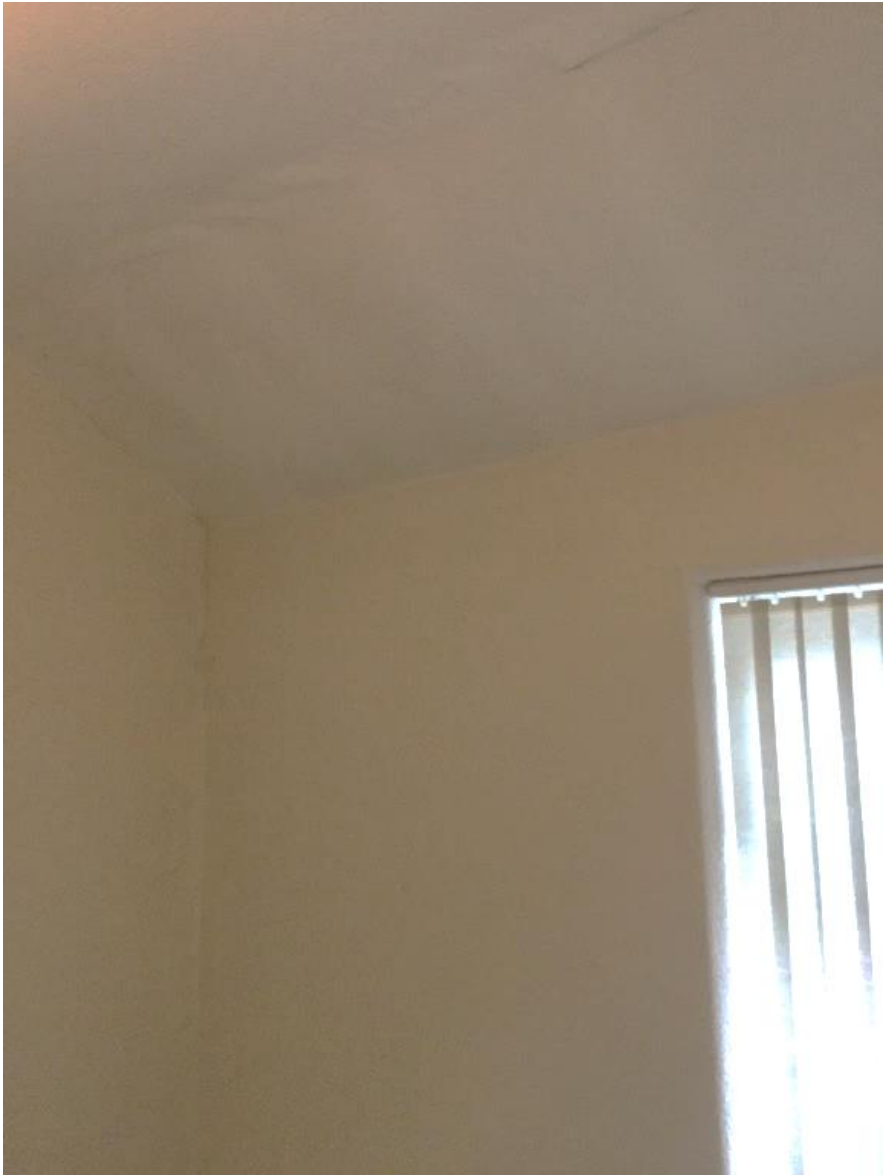
No	6.2.8
Location	First Floor, Landing
Zone	External Wall, Internal wall
Description	There is vertical separation of the wallpaper at the junction of the left hand external wall and the division wall of the front left bedroom and landing. There is disturbance of the ceiling at the junction of the vaulted and horizontal sections.
Photograph

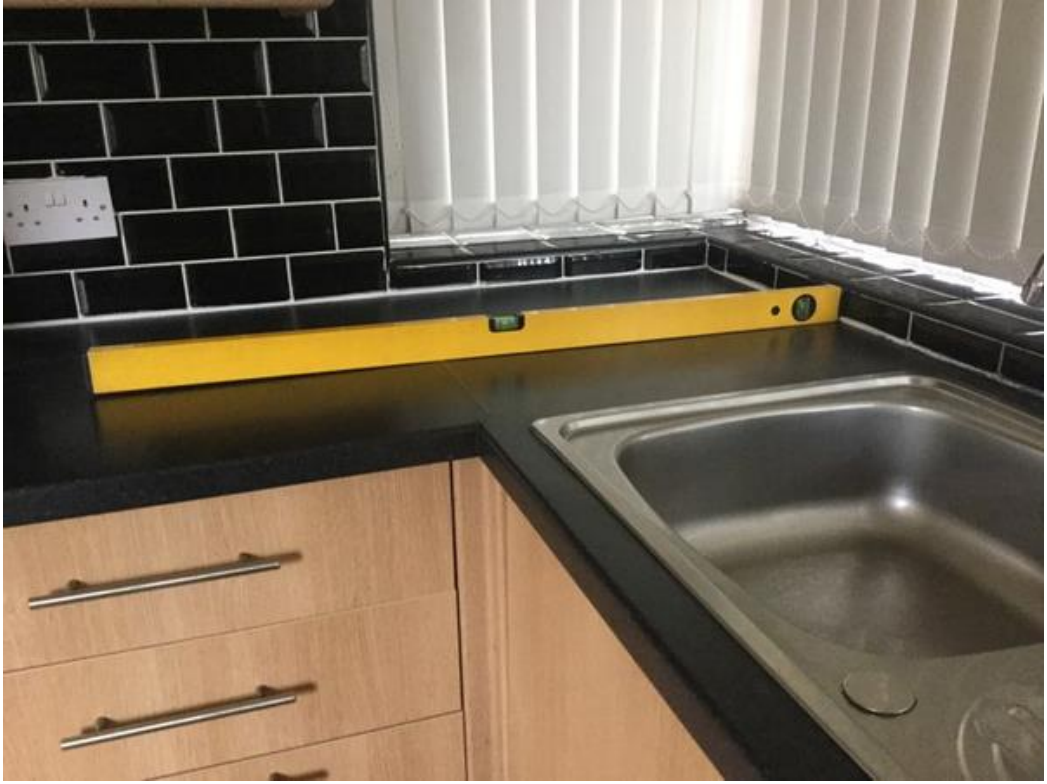
No	6.2.9
Location	Ground Floor, Kitchen
Zone	General Observation
Description	There is a fall of the side window cills of the bay and kitchen worktop where it projects into bay from right to left.
Photograph

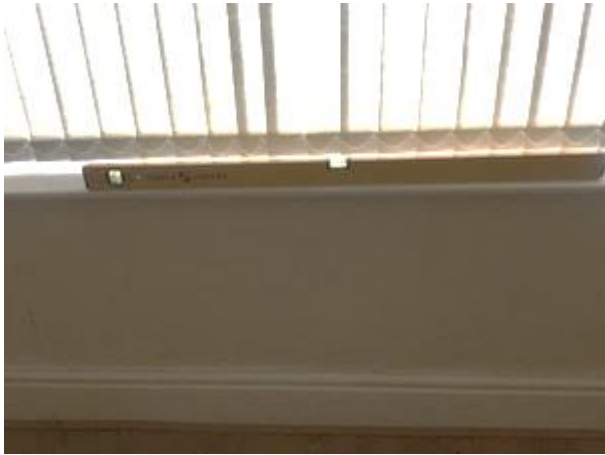
No	6.2.10
Location	Ground Floor, Rear Reception Room
Zone	General Observation
Description	There is a fall on the window cill from right to left and a slight fall on the floor in the rear left hand corner although the majority of the floor is to reasonable level.
Photograph

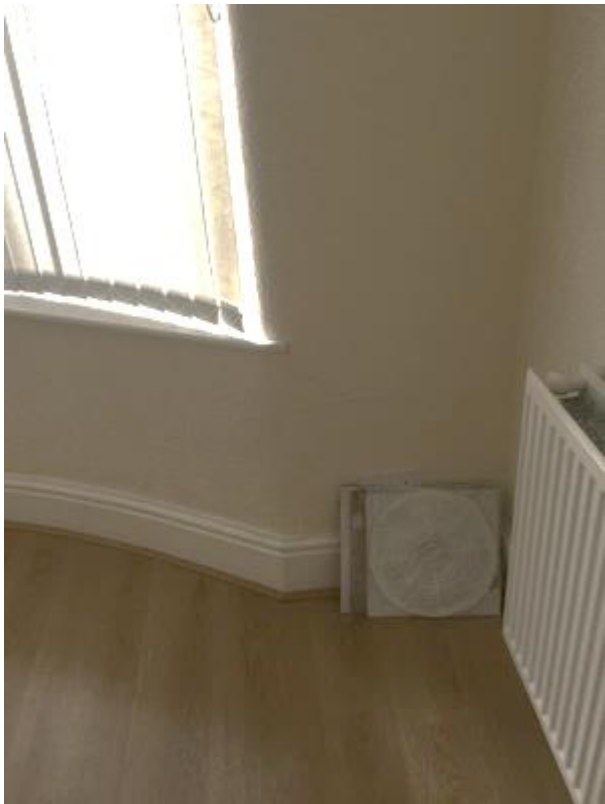
No	6.2.11
Location	Ground Floor, Front Reception Room
Zone	General Observation
Description	The bay cill and floor is to reasonable level, there is a short tear in the wallpaper below and to the right of the bay window and viewed from inside the room.
Photograph

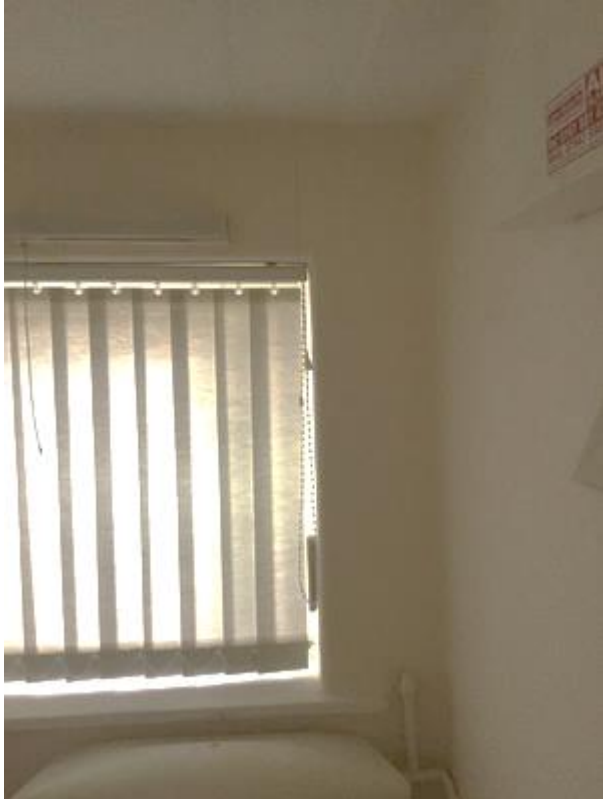
No	6.2.12
Location	Ground Floor, WC
Zone	External Wall
Description	There is a short vertical crack above and to the right of the window.
Photograph

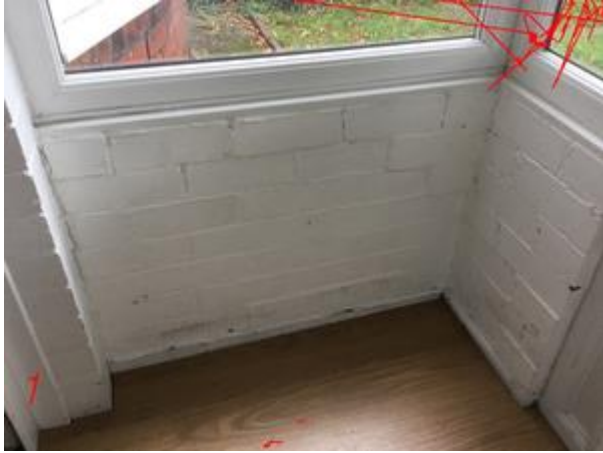
No	6.2.13
Location	Ground Floor, Porch
Zone	External Wall
Description	There is cracking in the porch at both sides where it meets the house and to the left of the door as viewed from inside the porch.
Photograph
