**Manchester City Council
Report for Resolution**

Report to: Resources and Governance Scrutiny Committee – 12 October 2017

Subject: Brookdale Park Huts

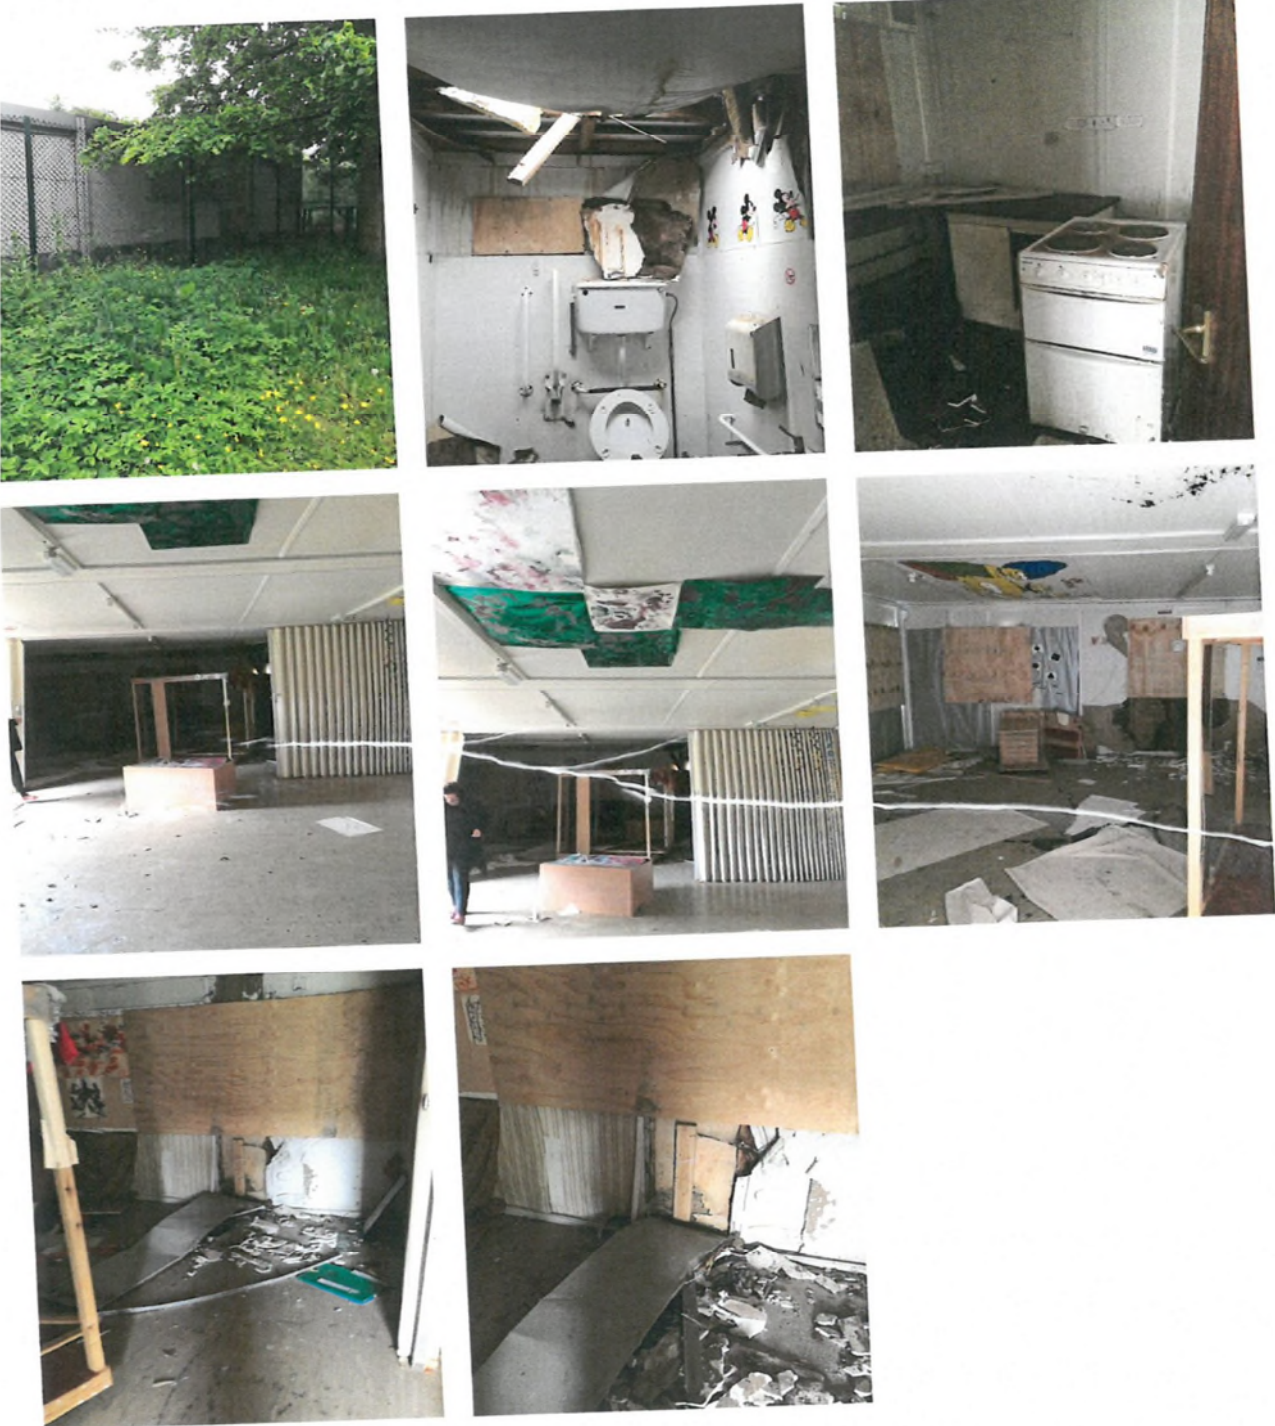
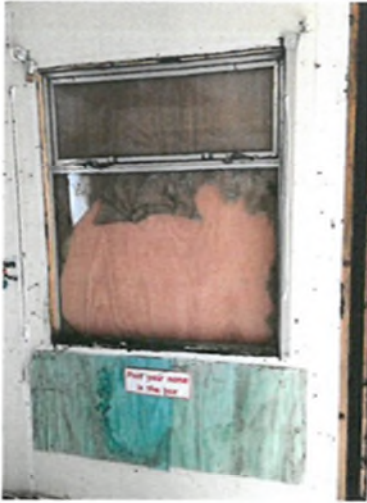
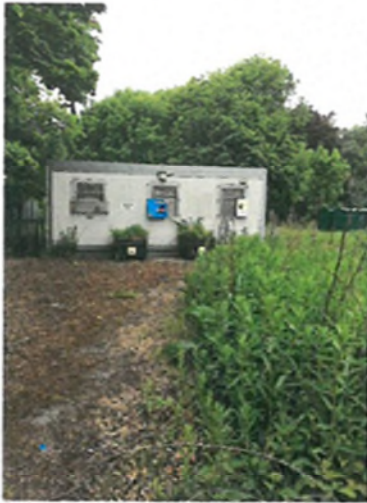
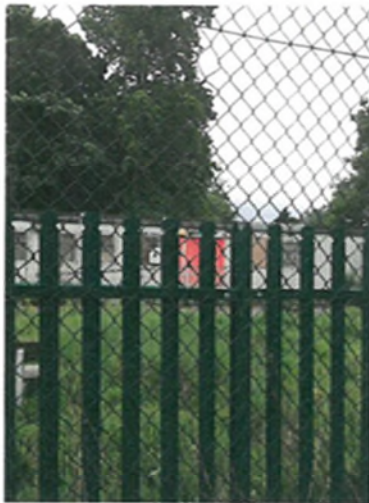
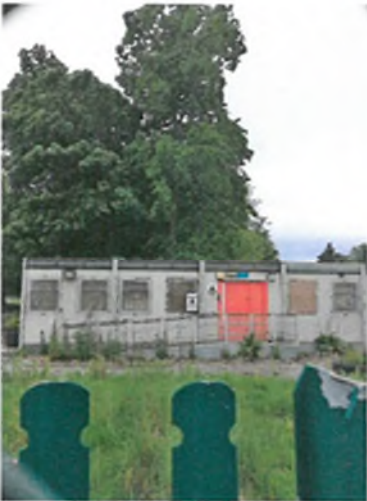
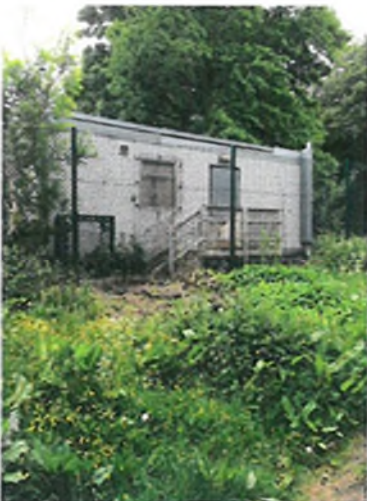
Appendix A

- 2.3 In 2013/14 a Building Surveyor and Structural Engineer were requested to visit the building and make an assessment, with a view to demolition. Their professional opinion was that the building was in very poor condition and that the structure had reached the end of its useful life. They noted that the panels were rotten, the roof had deteriorated in several areas and it would be easy for the property to be broken into by smashing through the panels, the door or roof.

- 3.1 Attached at **Appendix A** are a set of photographs of the hut (internal and external). As can be seen from these pictures the property is in such a poor state of repair it would be uneconomic to refurbish it.

- 2.9 Eventually the decision had to be taken to demolish the building.

- 3.4 An estimate cost of replacing the hut is £175,000 plus VAT, whilst the cost of demolition is estimated at £30,000. Both estimates include estimates for on costs, connection or disconnecting utilities, contractor costs, installation or disposal and contractor overheads and profit; and in the case of a demolition the removal of materials from site.
