MDPAG Polling Station Access Surveys 2019
Redeemed Christian Church of God Strong Tower Miracle Arena

MDPAG Polling Station Access Surveys 2019
St. Mary of the Angels and St. Clare, Parish Centre

MDPAG Polling Station Access Surveys 2019
Yes Building

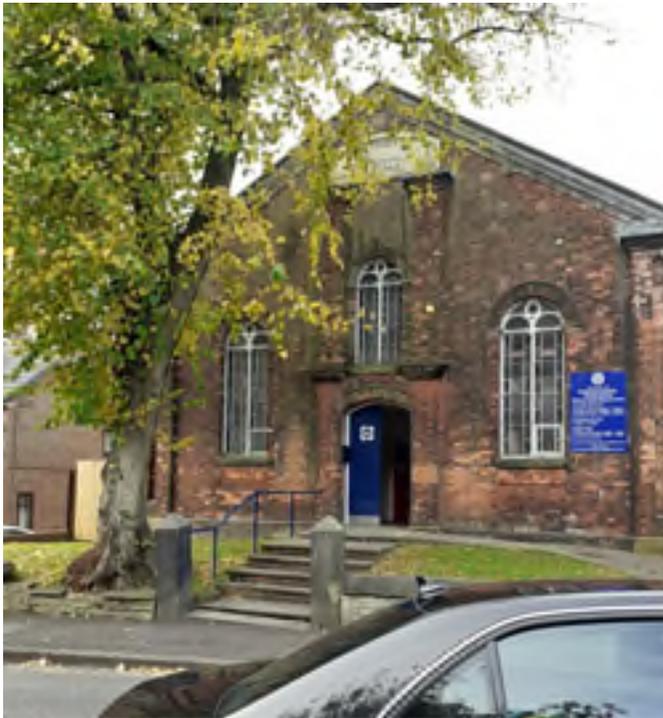
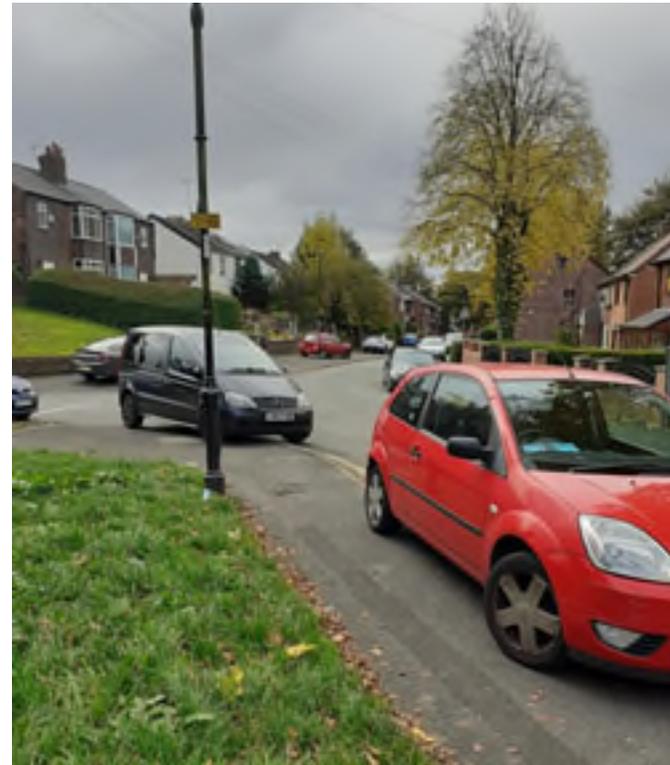
Main entrance route and parking spaces

Venue	Access	Notes
<p>1. Redeemed Christian Church of God Strong Tower Miracle Arena</p> <p>Contact: Taiwo Adegbola Visited on 21st October, 2019</p> <p>Surveyor: Flick Harris</p>	<p>Approach to the polling station</p>	<p>1.1 The approach to the church is along a narrow pavement and small road.</p> <p>1.2 There is no dedicated parking and cars park on the pavement because of the narrow approach road. This is an obstruction for visually impaired people in particular.</p> <p>1.3 There is no dropped kerb on to the narrow pavement.</p> <p>1.4 The church is accessed by steps and a ramp. The steps are very uneven with gaps between them. There is a handrail only to one side. The ramp has no handrails although it has a gentle gradient. There is no colour contrasted indication at each end of the ramp and the steps have no contrasted colour on the nosings. I was told that most people use the ramp.</p> <p>1.5 The main entrance door is double leaf and when both are open it is adequate at 1300mm</p> <p>1.6 The second set of doors are 1200mm wide when both sides are kept open. I was informed that on polling day, both doors will be held open but the minister was concerned about fire regulations.</p>

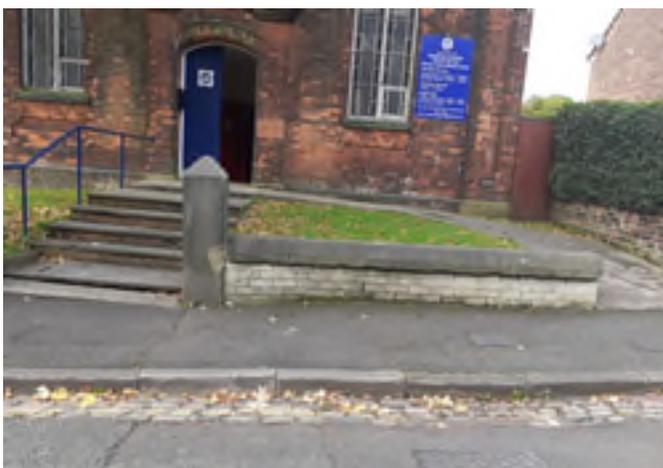
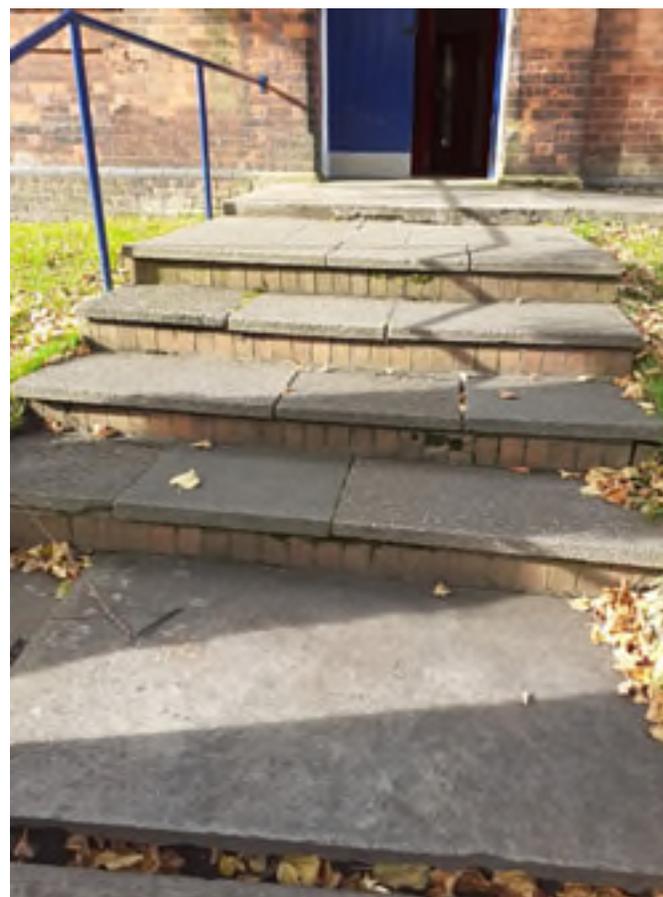
Steps and ramp

<p>1.8 It is recommended that the main church hall, directly opposite to the main entrance, be used for polling purposes. The minister indicated that this would be acceptable. The chairs down one side would be moved.</p> <p>1.9 The doors to the main hall would both have to be kept open. The width of both open doors is 1200mm</p>
	Room to be used as the polling station	<p>1.10 The main church room would be suitable for wheelchair and scooter users</p> <p>1.11 The floor surface is smooth and non-slip and non-reflective.</p> <p>1.12 The lighting is rather uneven but the minister demonstrated how the curtains could be opened, letting in more daylight.</p>
	Other facilities or barriers	<p>1.13 There is no accessible toilet. There are plans to build an extension for an accessible toilet and to improve the ramp in the future.</p>
	Recommendations	<p>1.14 The building requires clear external and internal signage</p> <p>1.15 The polling station should be located in the church if the venue is used.</p> <p>1.16 However, access to the church, particularly by the steps, is unsafe and requires maintenance. The ramp requires handrails and there is no accessible toilet.</p>

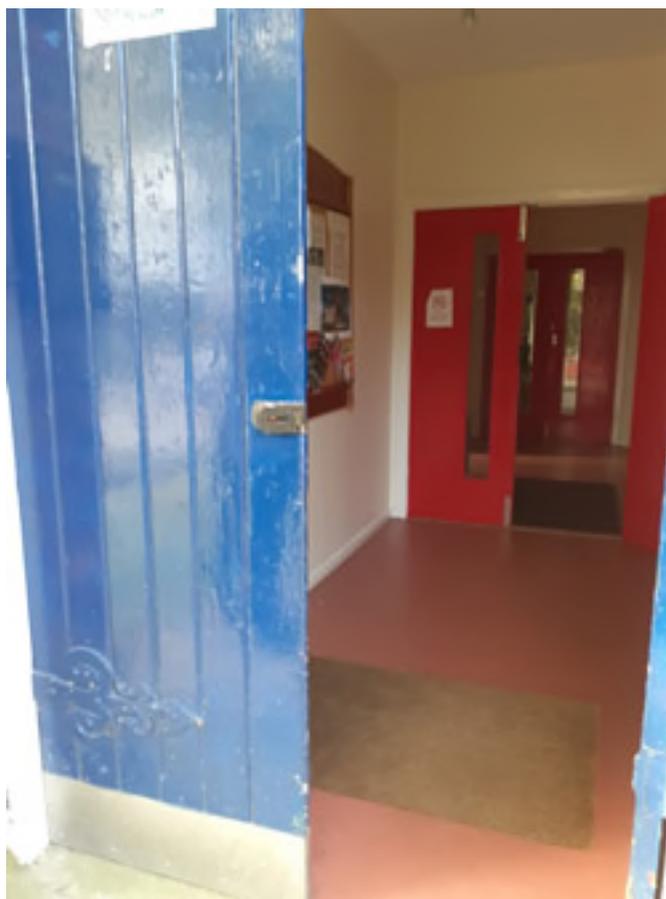
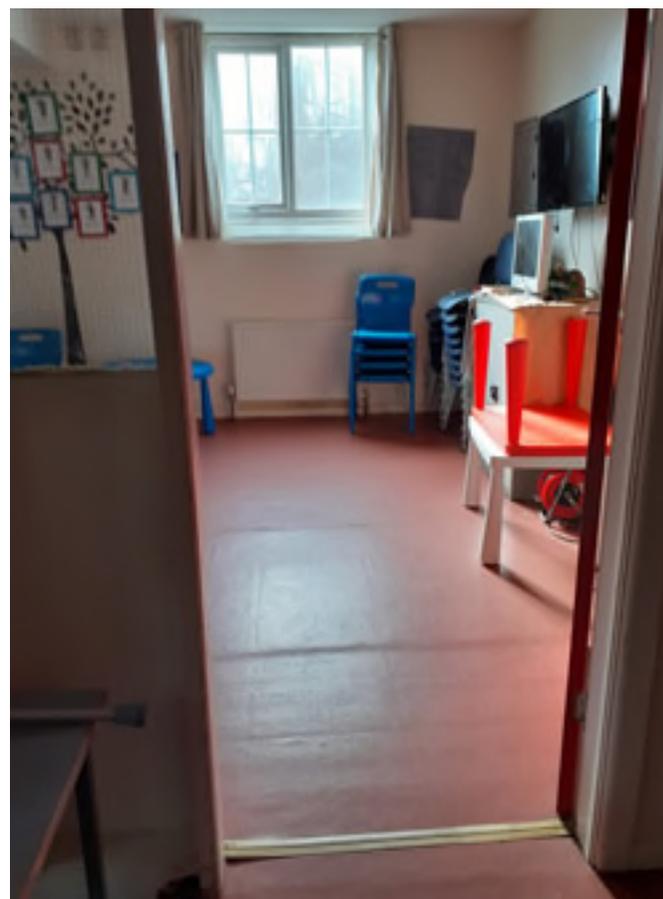
Entrance doors to main building area and to small room

<p>Internal route to the area to be used as the polling station</p>	<p>1.7 It was envisaged that a small room, immediately to the left of the second entrance doors, would be used as the polling room. However, the width of the door to the small room is only 760mm which would not be wide enough for all wheelchair users and others with assistance dogs or needing other assistance. Design for Access 2 recommends a minimum of 850mm.</p>

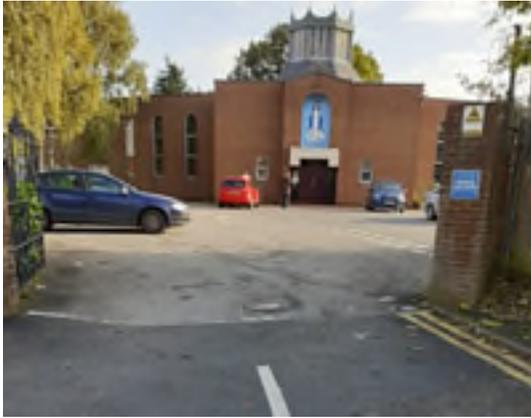
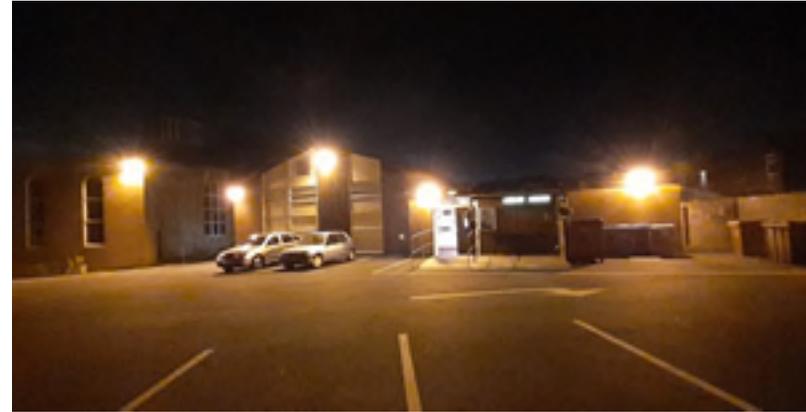
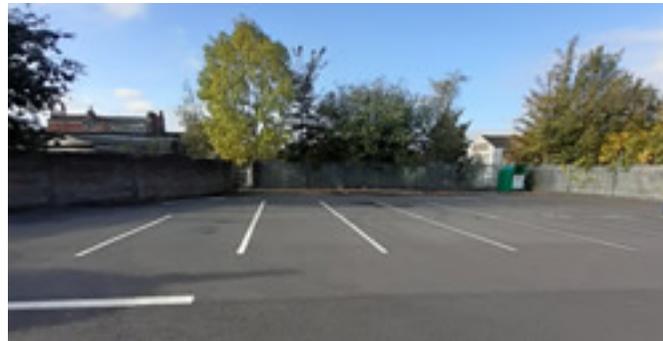
External signage, main entrance route and selection of parking spaces

Venue	Access	Notes
<p>1. St Mary of the Angels and St Clare, Parish Centre</p> <p>Contact: Jennifer Jones Visited on 20th and 23rd October, 2019</p> <p>Surveyor: Flick Harris</p>	<p>Approach to the polling station</p>	<p>1.1 The Community Centre building is located to the right of the church and the entrance is not very well lit at night but should be easily recognised if there is adequate signage to the polling station.</p> <p>1.2 The main church is easily seen, has a wide vehicle and pedestrian entrance. The entrance, ramp and door needs better signage for occasional visitors. Good polling station signage is required.</p> <p>1.3 There are many parking spaces in front of the church and in front of the Centre which is to be used for polling purposes. There are marked out accessible parking spaces in front of the main church building though they are a short walk away from the centre. However, there would appear to be sufficient parking spaces overall.</p> <p>1.4 There is a ramp to the main entrance of the Centre with handrails to both sides. The ramp has no upstands on the left side on approach to the building but the edge could be highlighted with coloured paint well contrasted with the surface of the ramp.</p> <p>1.5 The ramp is reasonably contrasted with the roadway but the handrails are set high at 1600mm and are metal and not warm to the touch. Paint could also be used to indicate the bottom and top of the ramp. The handrails to the right side of the building finish before the entrance but this space will be enclosed with each door kept open on the polling day.</p> <p>1.6 The width of the main entrance door which double sided is 760mm x 2 (1520mm). I was advised that both doors would be kept open for polling day which would be sufficiently wide for everyone.</p>

1.16 There is also access to male and female toilet facilities in the area opposite the main door
	Recommendations	1.19 The building requires clear external and internal signage. 1.20 The polling station would be more accessible if moved from the smaller room to the main hall. 1.21 Doors should be kept open during polling hours. 1.22 The edge of the ramp, where there is a drop and no upstand, should be marked with colour contrasted paint to indicate a hazard. 1.23 The emergency cord in the accessible toilet should be extended to the floor in case someone falls so that it is reachable.

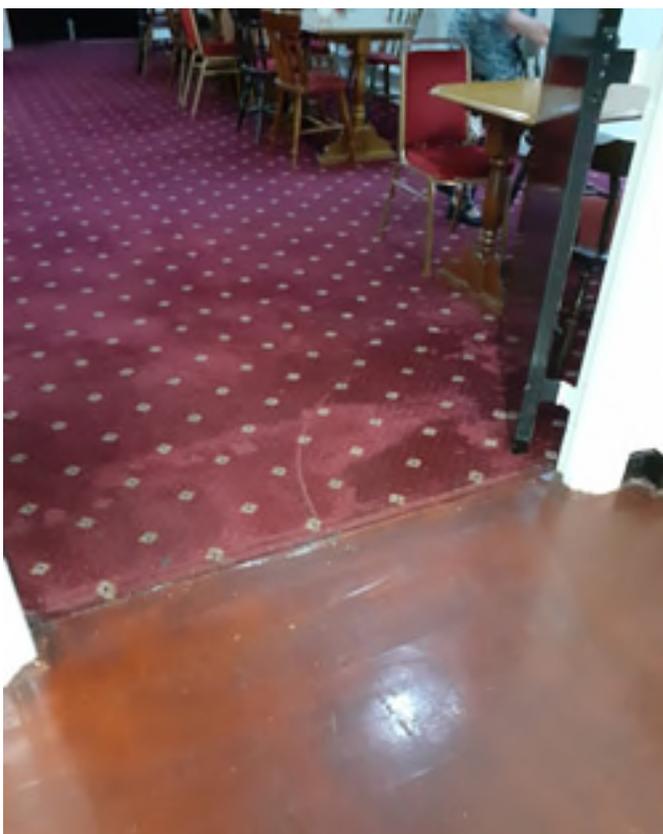
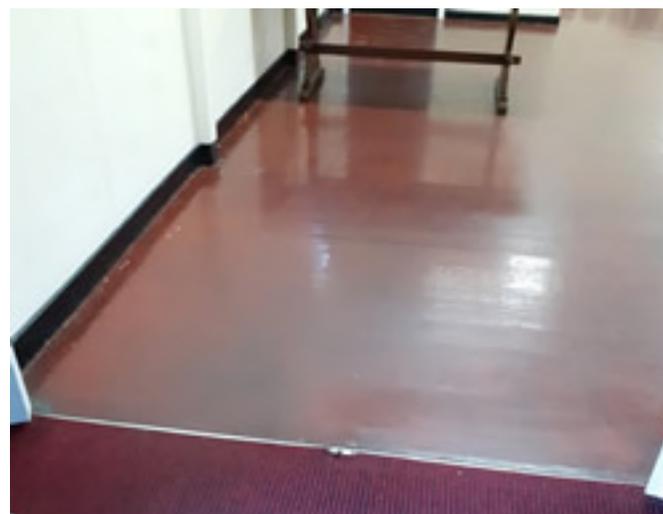
Internal doors to small room and to hall

Internal route to the area to be used as the polling station	<p>1.7 It was envisaged that the small room, immediately opposite to the main entrance would be used as the polling room. However, the width of the door to the small room is only 820mm which would not be wide enough for all wheelchair users. Design for Access 2 recommends a minimum of 850mm. It would be confusing to some people to enter via the hall and then enter via a set of doors. Also entering through the small door takes people past a row of tables and chairs.</p> <p>1.8 The carpet is pink and patterned and the chairs are a similar colour so could be confusing for some visually impaired people.</p> <p>1.9 It is recommended that the main hall, next to the smaller room be used for polling purposes. The venue representative indicated that this would be acceptable.</p> <p>1.10 The doors to the main hall would both have to be kept open. The width of the doors are approximately 700mm x 2 (1400mm)</p>

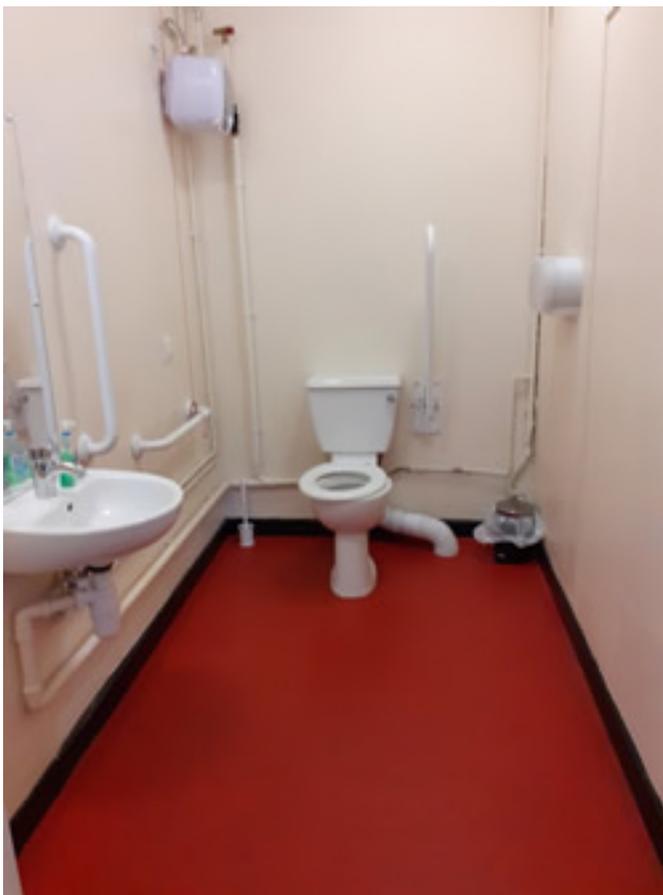
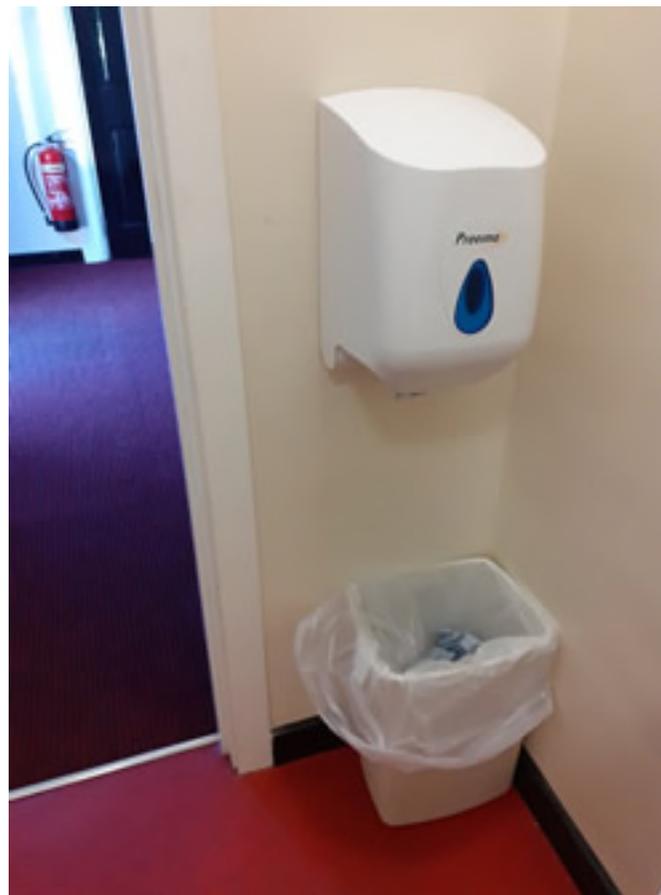
Accessible toilet

Room to be used as the polling station	<p>1.11 The hall is accessible for wheelchair and scooter users and is well lit.</p> <p>1.12 The floor surface is smooth and non-slip although somewhat reflective. This should be alleviated with the location of polling booths, tables and chairs.</p> <p>1.13 The room is regularly used for community activities.</p>
	Other facilities or barriers	<p>1.14 There is an accessible toilet. The emergency cord was tied up and this was discussed with the venue representative, who agreed to extend the cord to the floor. The fixtures and fittings are white against a white background and it was recommended that the walls are painted a dark colour such as blue to contrast the fixtures and fittings for visually impaired people. There was a bin located under the hand dryer and it was recommended that this bin was moved to another place, other than to the transfer space. The transfer space was a bit restricted particularly by pipes but probably sufficient for polling purposes in the short term. The floor was clearly contrasted with the walls. There is a flashing alarm for people who are deaf or hard of hearing as well as standard emergency alarms, which we tested on the visit.</p> <p>1.15 There is access from the hall for staff to a small kitchen area with washing facilities, fridge and cooking facilities.</p>

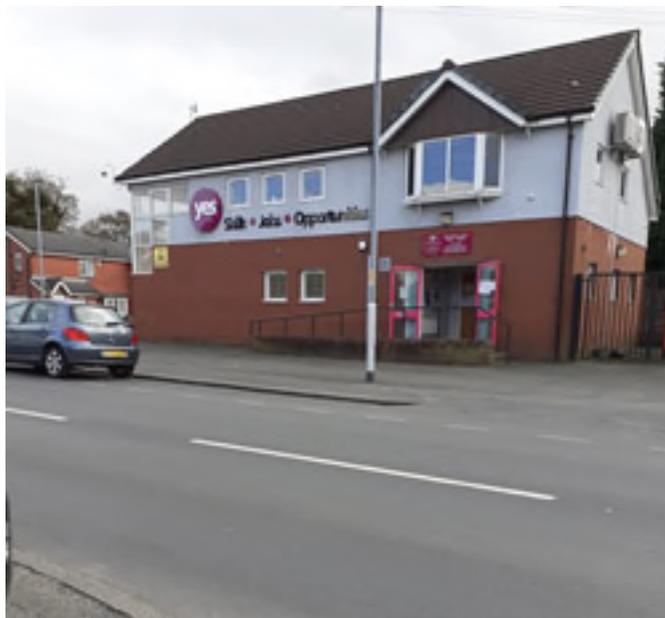
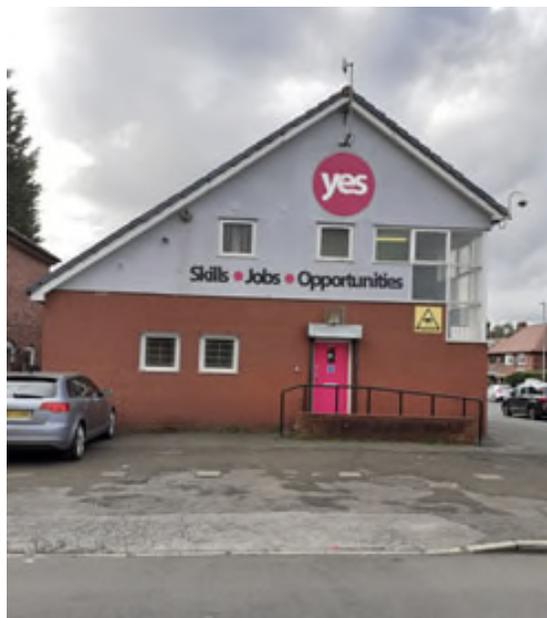
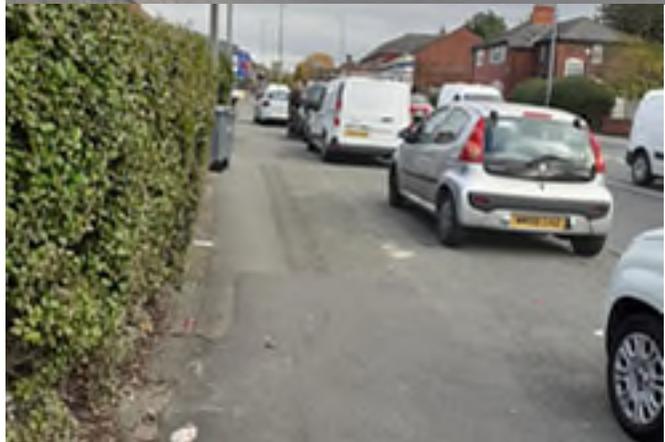
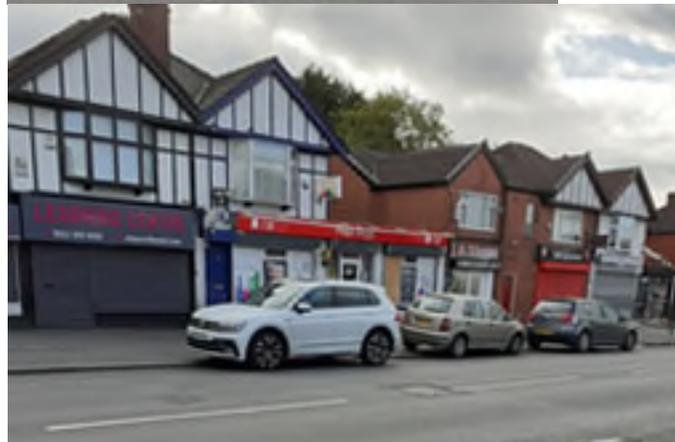
Main building and parking in the vicinity

Venue	Access	Notes
<p>1. Yes Building</p> <p>Contact: Ike Obe Visited on 21st October, 2019</p> <p>Surveyor: Flick Harris</p>	<p>Approach to the polling station</p>	<p>1.1 There is a side door with steps and a ramp and both have handrails but only on one side. Neither the steps nor the ramp are highlighted at the bottom or top and the steps are not highlighted on their nosings. There are plants and grass around the end of the ramp which need to be removed. This door is not generally used.</p> <p>1.2 The Yes building is well signposted and is located on a main road with many buses travelling the route. Bus stops are near to the entrance.</p> <p>1.3 There are a small number of parking areas along the road which are normally occupied and many cars park on the pavements, which is a bit hazardous for pedestrians. However, there is also parking along the side roads near to the Centre.</p> <p>1.4 There is no dropped kerb in the front of the Centre but there is one at the side entrance, where there is also room for a small number of cars to park, although parking spaces are not marked out. It would be helpful to have at least one space at the side of the building marked as an accessible parking bay.</p> <p>1.5 The steps at the main entrance have a handrail only to one side and are not highlighted at the top and bottom or on the nosings. They also need maintenance to remove rubbish and weeds.</p> <p>1.6 The ramp has a handrail only to one side and is not highlighted at the top or bottom and has no tactile or visual warning of a change of level. The ramp needs regular maintenance to remove weeds at the bottom.</p>

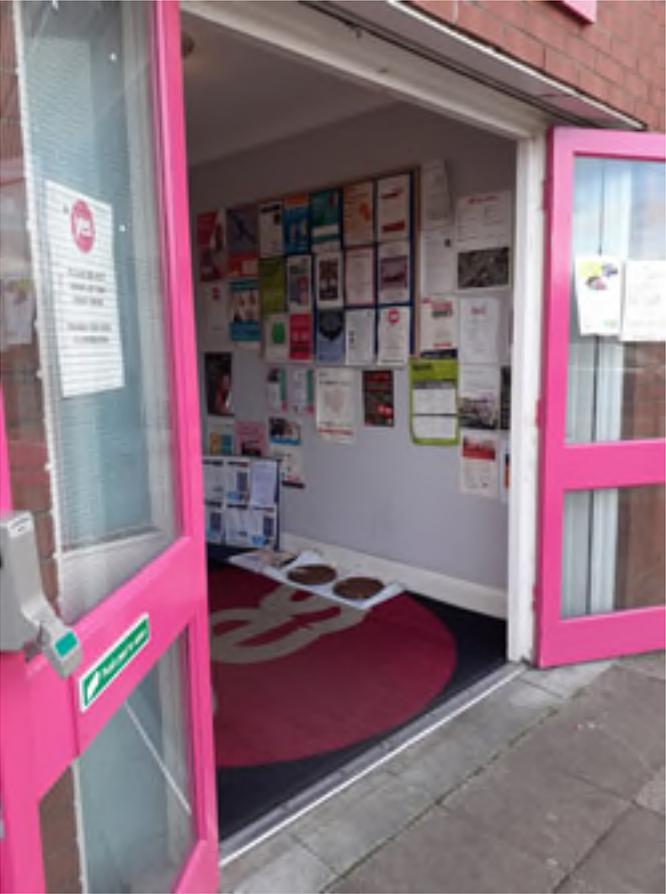
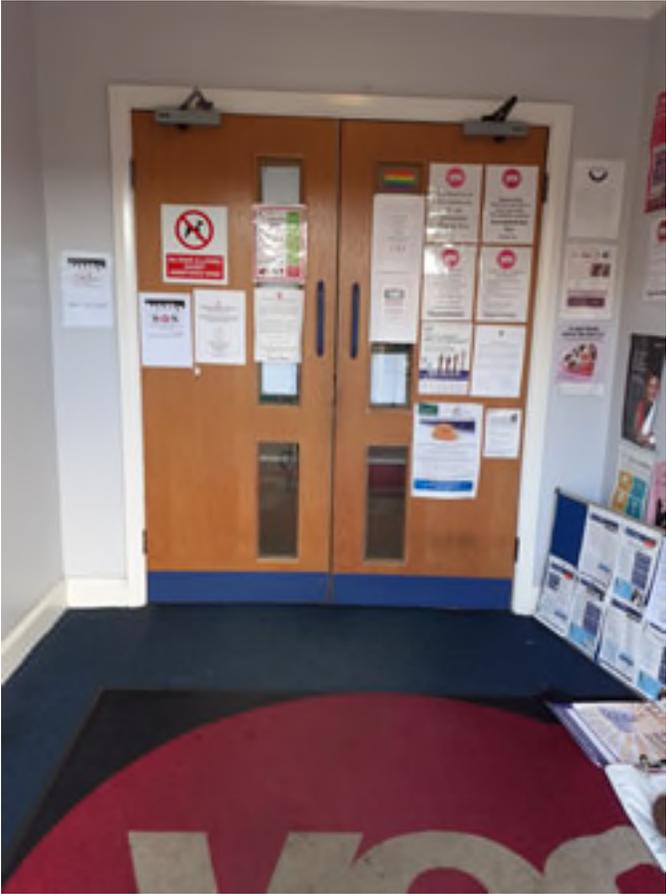
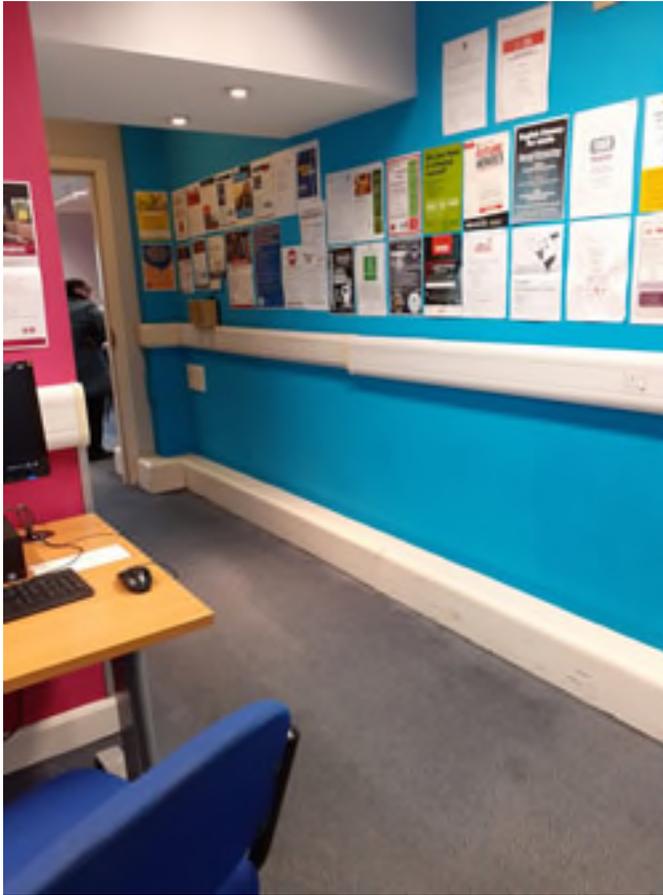
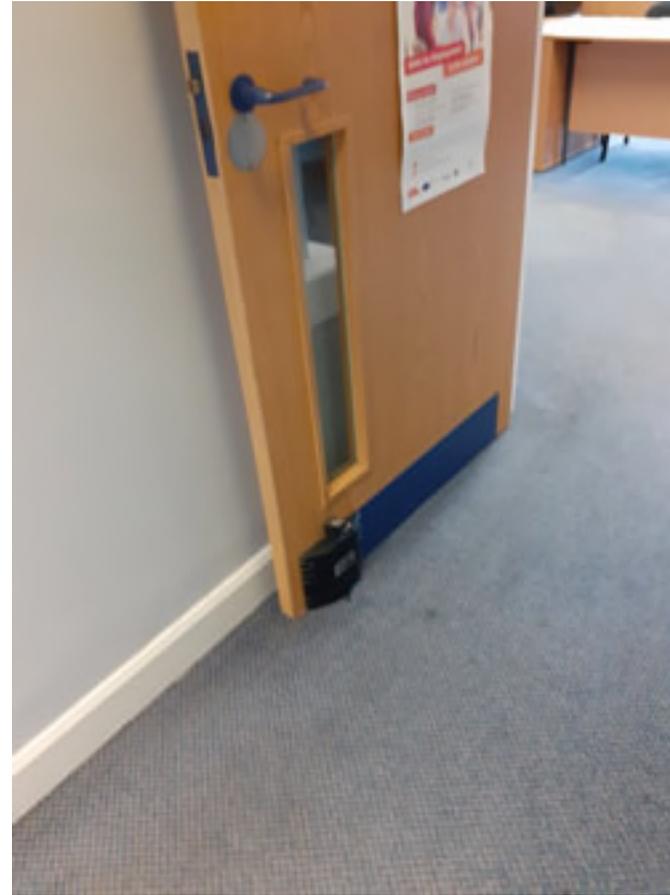
External, internal doors and corridors

<p>1.7 The pink main entrance door is 1500mm wide when both doors are open, and is well contrasted with the building and the approach.</p> <p>1.8 There are two interior doors which are generally closed and it is recommended that they are kept open during the polling day to ensure accessibility. There may be a security issue if this recommendation is followed so staff may need to supervise to ensure the safety of the many computers in the building.</p>
	Internal route to the area to be used as the polling station	<p>1.9 Voters would enter the reception area which has computers that can be used by visitors, a reception area with seating and a reception desk, an accessible toilet, a small corridor to an office and a small corridor to a main area with computers for use and a large table, and another small corridor to the room suggested for the polling station and access to stairs and other office facilities. The door width from the corridor to the main area is approximately 840mm which is a bit small but probably adequate for most wheelchair users. There would be no alternative provision in the building.</p>

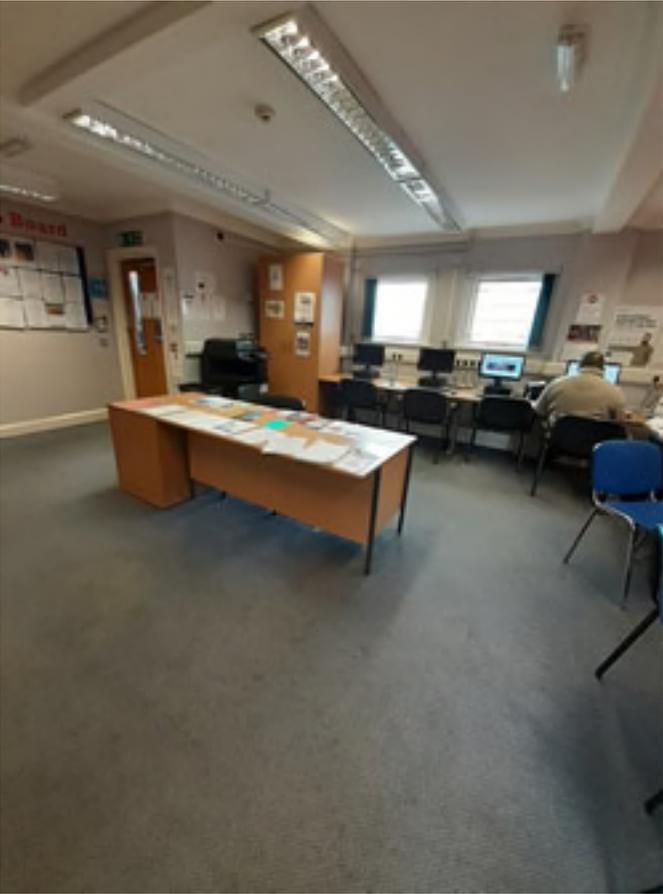
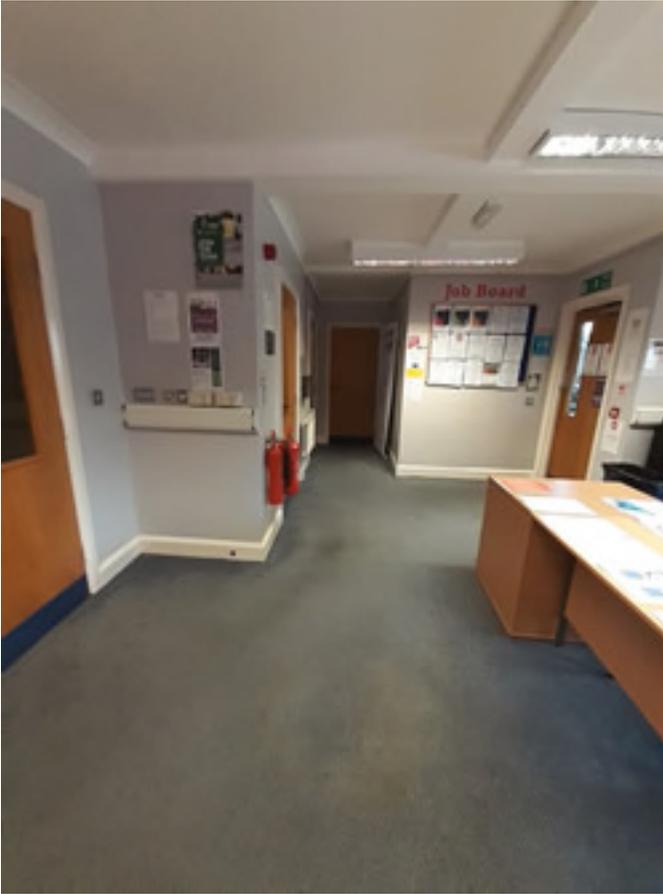
Main computer room and corridor to small proposed polling station room

Room to be used as the polling station	<p>1.10 The room initially considered for polling is at the end of a small corridor which is quite dark. The width of the door is only 730mm so it is recommended that the main area is considered for voting. The Centre manager was not sure if this was possible, as there are people coming and going in this area and using the computers along the window and wall.</p> <p>1.11 The small room is light and adequate for use as a polling station but the doorway would not be accessible for most wheelchair users. It is suggested that further discussions should take place with the centre manager about the use of the main space.</p>
	Other facilities or barriers	<p>1.12 There is an accessible toilet available for everyone which although there are some design faults, would be acceptable in the short term.</p> <p>1.13 The handle is high at 1300mm from the floor to the top, there is no shelf for ostomy users and the lever taps are small. It would be useful to have paper towels as well as a hand dryer for neuro-diverse people as some may find the sound of a dryer upsetting. A long mirror would be more useful for wheelchair users. The handles and locks on the door are not standard Doc M design to meet Building Regulations and BS 8300 standards, and it is not very clear</p>

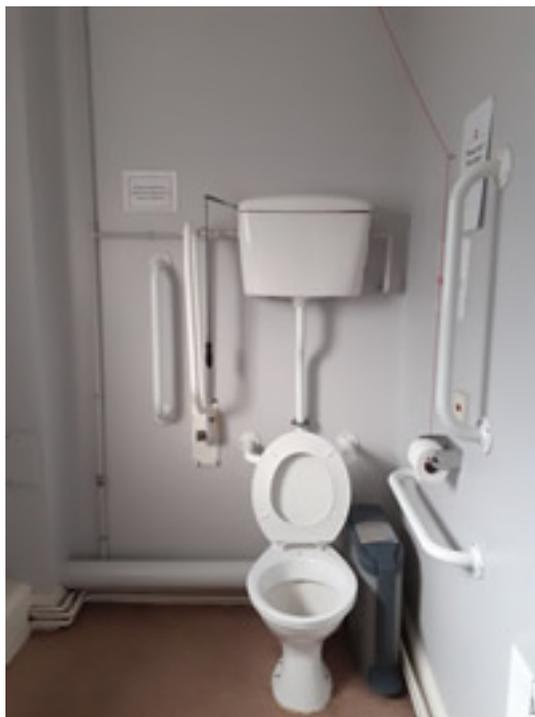
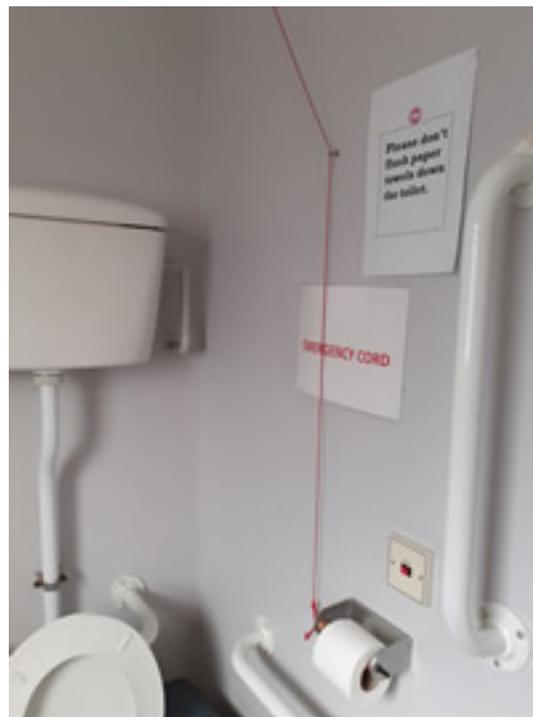
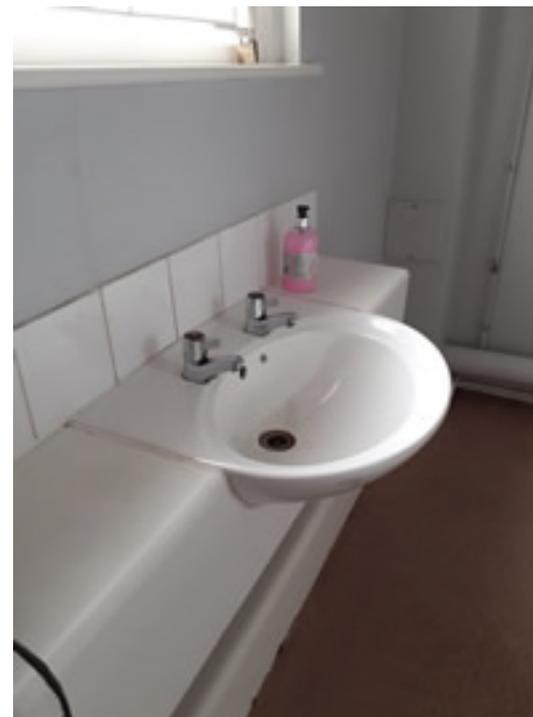
Accessible toilet

<p>when the toilet is engaged. However, the main facilities are acceptable in the short term.</p> <p>1.14 There is no flashing alarm to indicate to people who are deaf or hard of hearing that there is an emergency.</p> <p>1.15 The transfer space is adequate for some wheelchair users but some wheelchair users transfer from the front.</p> <p>1.16 The alarm cord was tied up and not to the floor but the manager agree to extend the cord to the floor.</p> <p>1.17 There is no colour contrast between the fixtures and fittings and the walls and the manager agreed to consider painting the walls a dark colour to highlight the facilities for visually impaired people.</p> <p>1.18 A flashing alarm should be installed in the toilet for people with hearing impairments.</p>
	Recommendations	<p>1.19 The building requires clear external and internal signage to the polling station area.</p> <p>1.20 The polling station would be more accessible for wheelchair users if it is located in the main computer area space instead of in the small room.</p> <p>1.21 The alarm cord in the toilet should be extended to the floor.</p> <p>1.22 The ramps and steps around the building should be regularly maintained to allow for smooth access along the routes.</p> <p>1.23 There are more long term issues in the building which would benefit from a fuller access audit and funding to make the building more accessible overall for all its activities.</p>
